Property Inspection Report

1234 N Apple Ave, Chicago, IL 60600

Date of Inspection: 5/6/2013 Time: 12:00PM

This is a sample Commercial property report

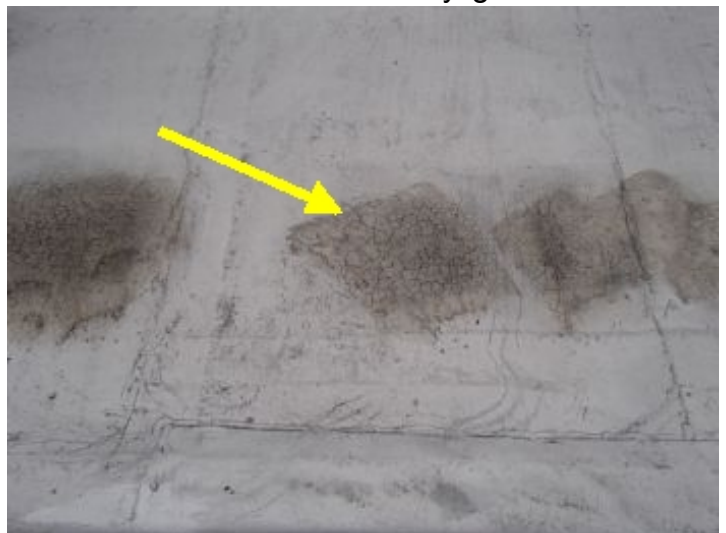
Some alligating wear on roof

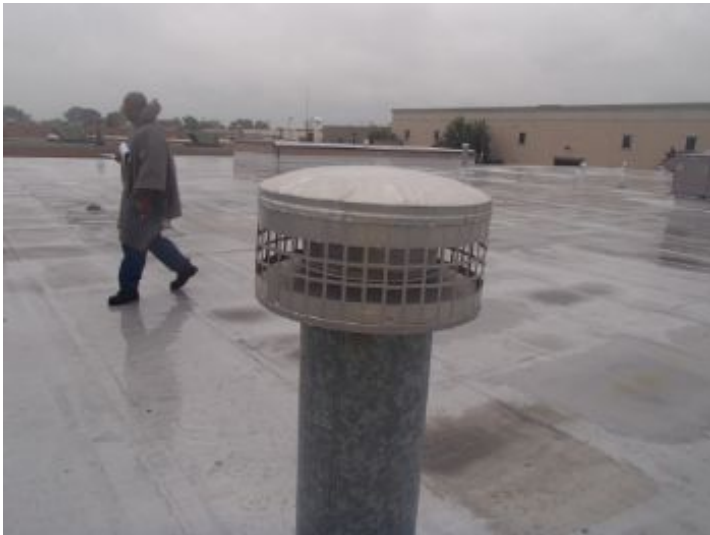
Roof ventilation from heating units

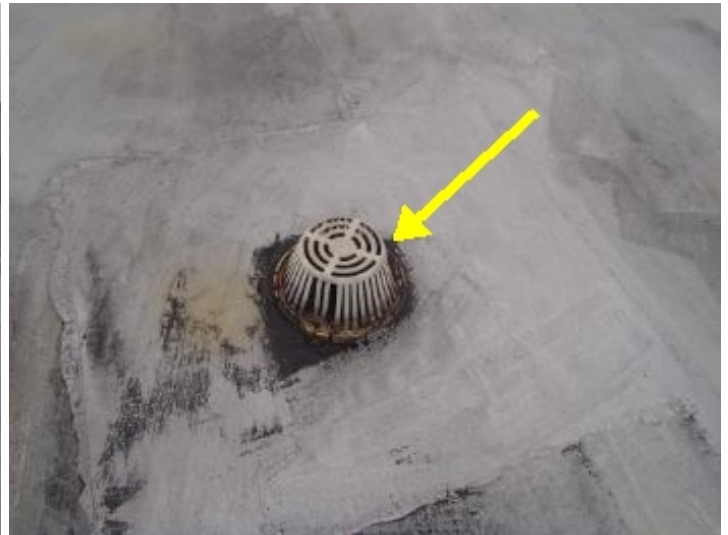
Roof drain - only 2 found

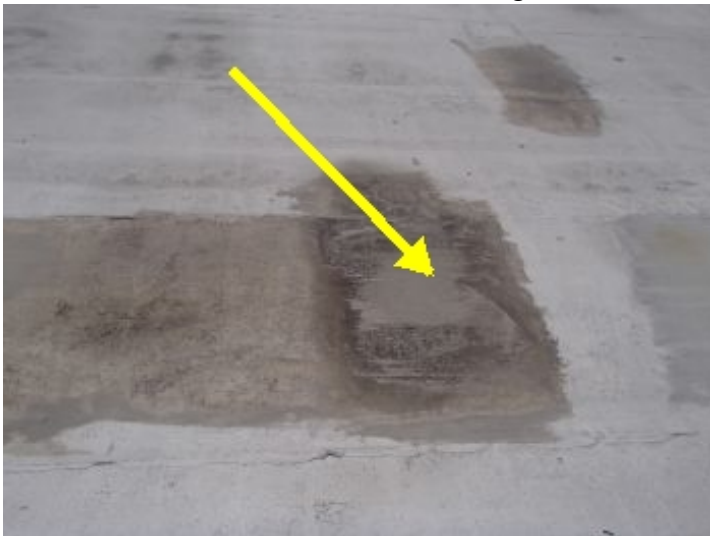
Ponding evidence

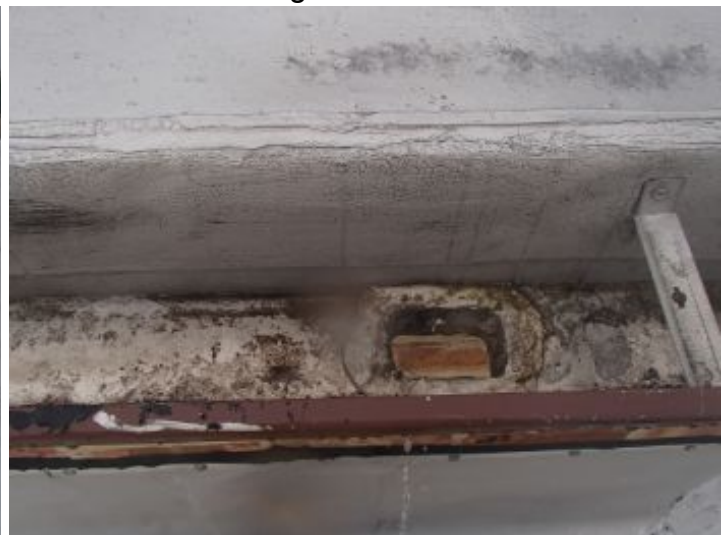
Gutter of higher elevation damaged wear

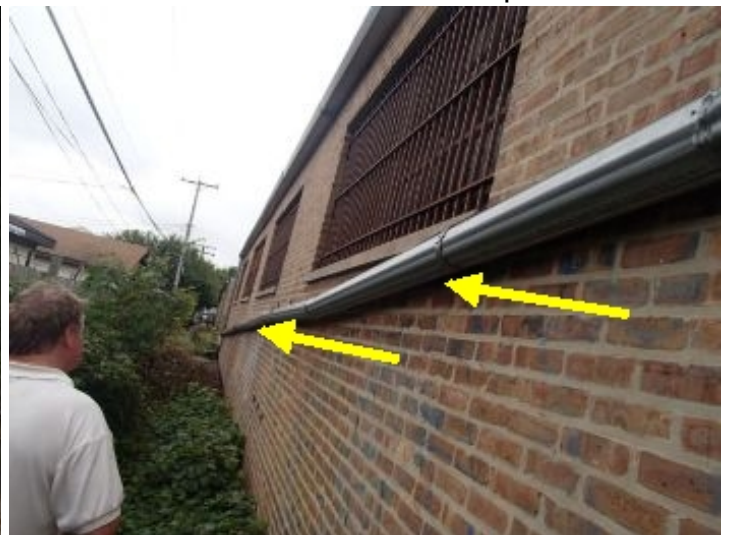
Drain pipe on east side wall directed to south parking lot

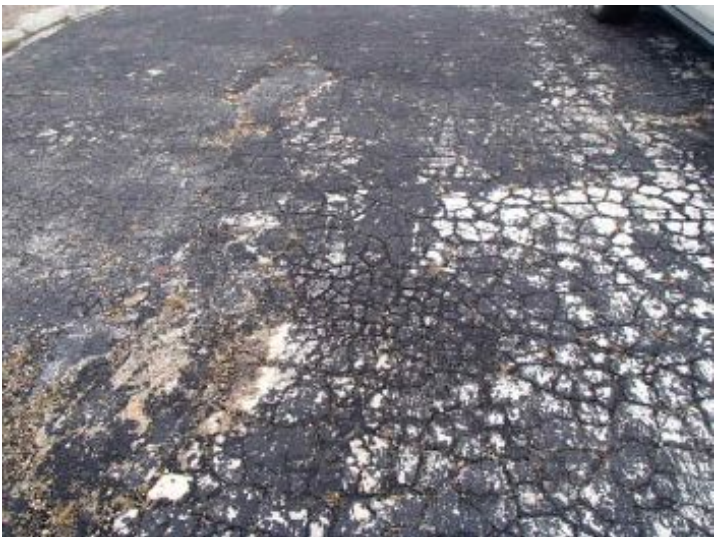
The North parking lot is mostly aged asphalt with severe alligating (numerous cracks resembling alligator skin). Recommend resurfacing.
The south driveway is concrete with common cracks noted

Parking lot alligatoring

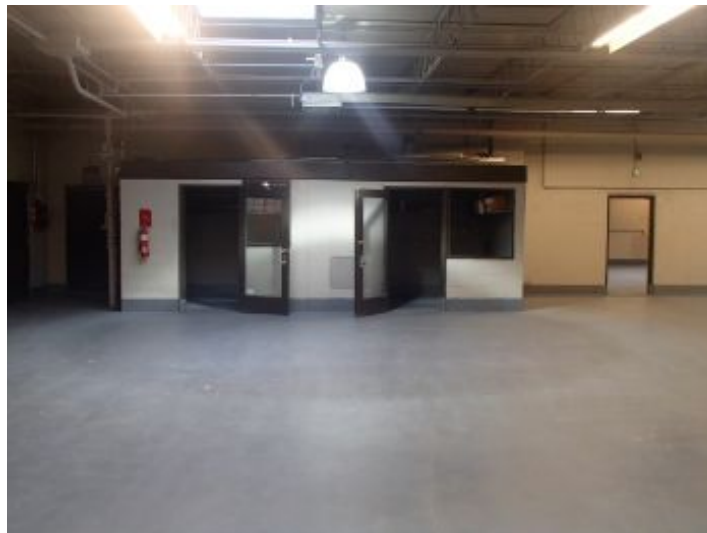
Foundation slab basically flat- minor cracking

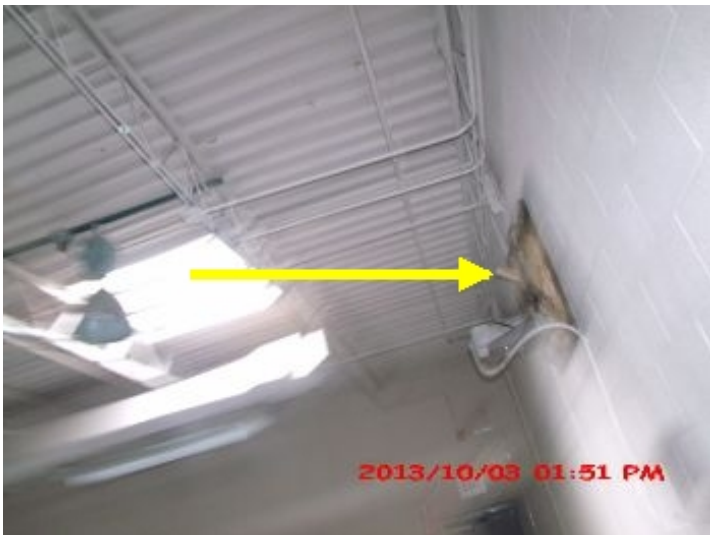
Exhaust vent in rear of North warehouse filled with insulation

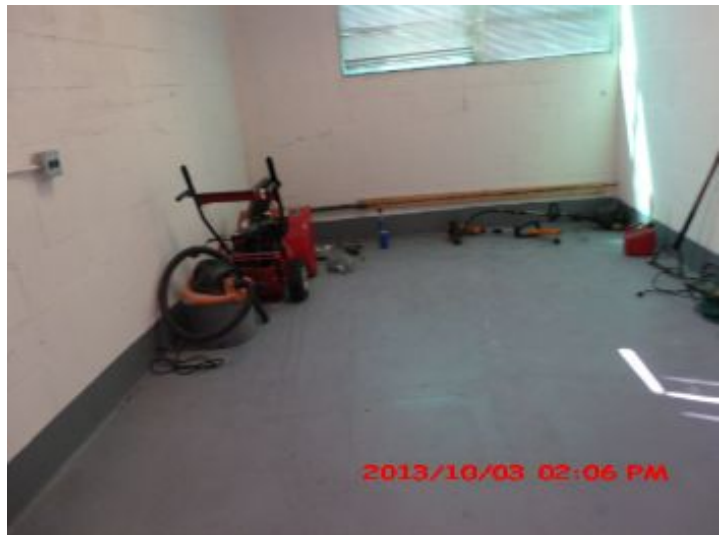
Southeast storage room - no apparent heating supply noted

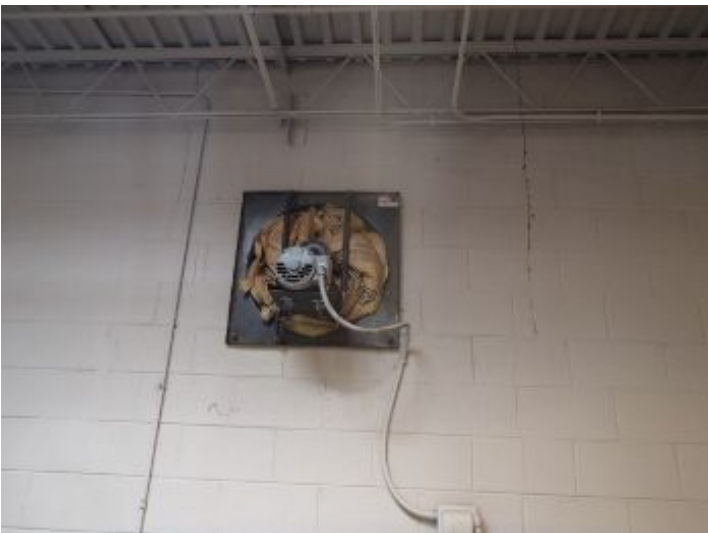
North warehouse rear - exhaust fan noted filled with insulation. Do not operate

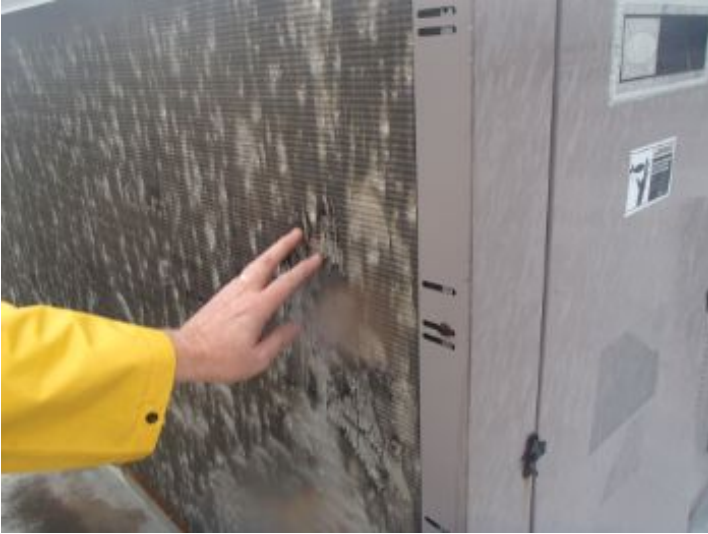
Rheem rooftop unit - AC fins badly damaged - suggest repair

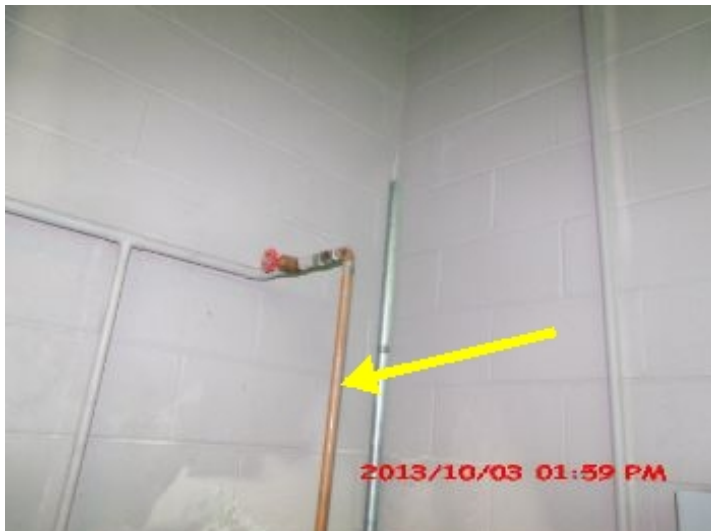
Electric water heater TPRV Valve not extended to floor

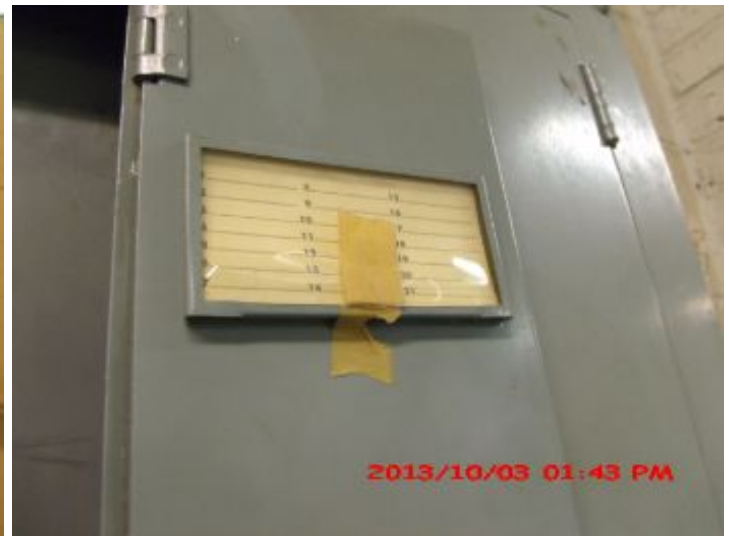
No labels noted on breaker box

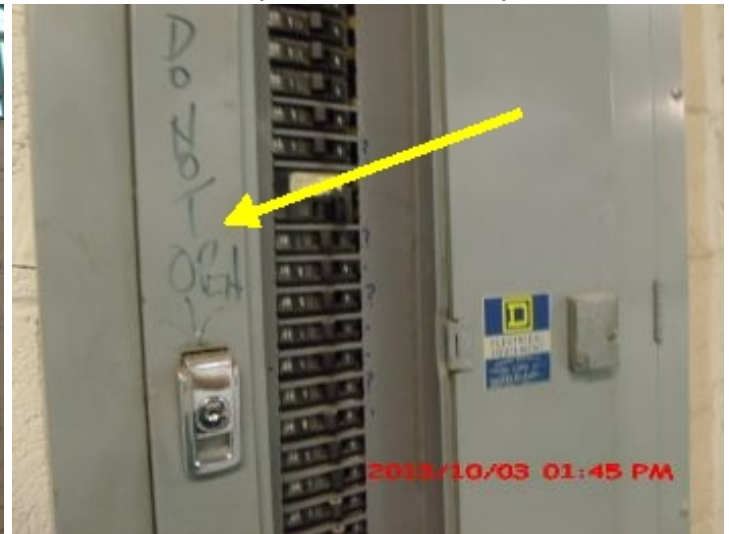
Dangerous ams - to not open

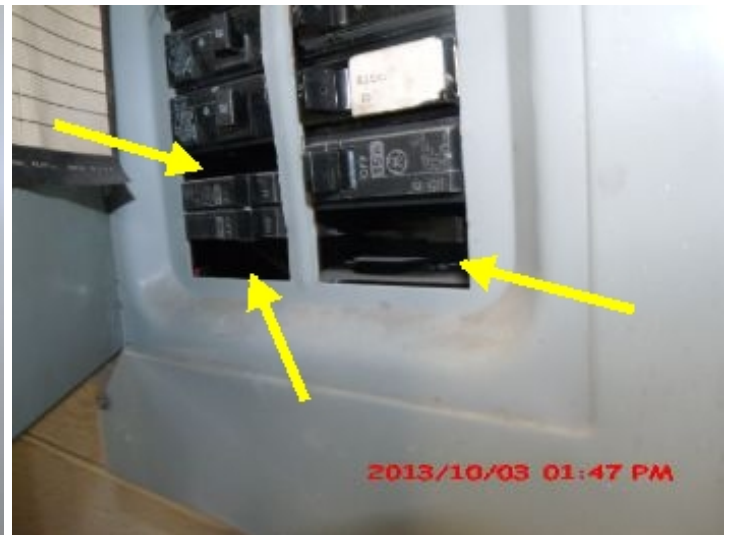
Panel #1 has missing break covers - dangerous

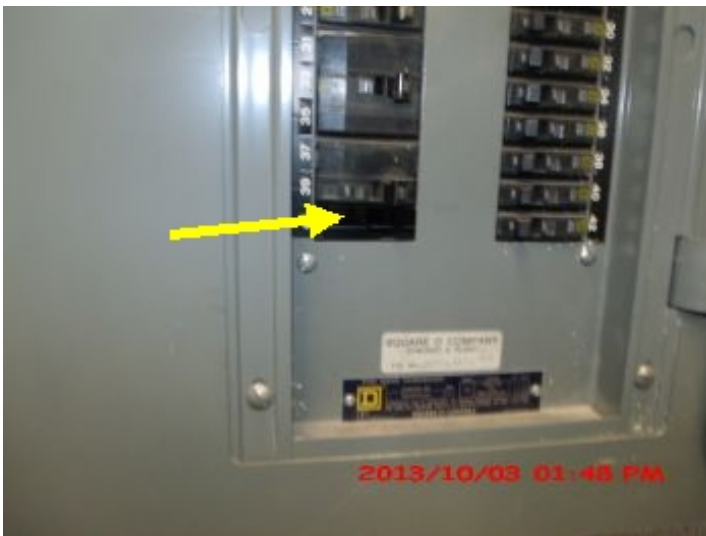
Another panel missing breaker cover

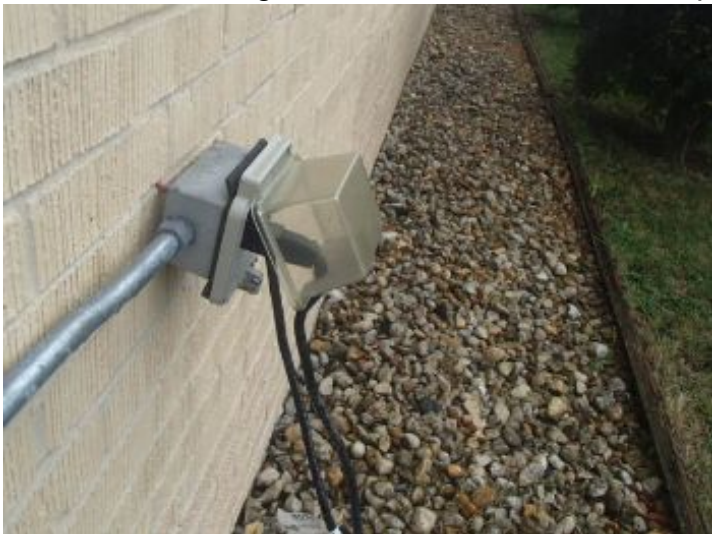
Concern that sump pump socket not in waterproof condition

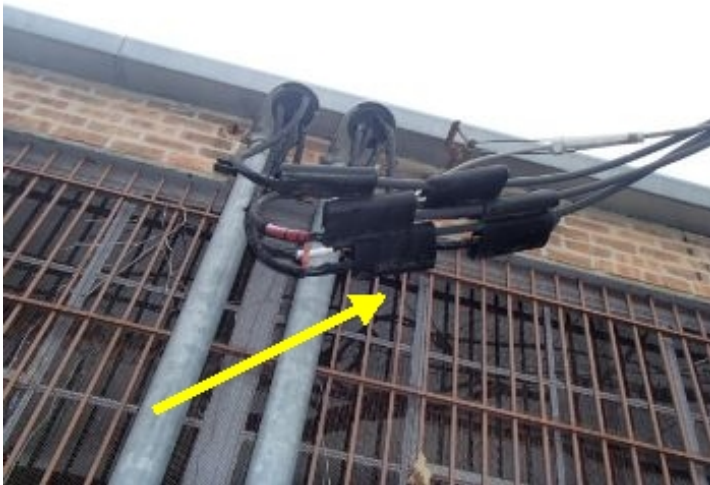
Concern that main mast is close to ground level, only about 9 feet away.

Overhead mast - concern being close to ground level

Recommend having electrical service check for code.

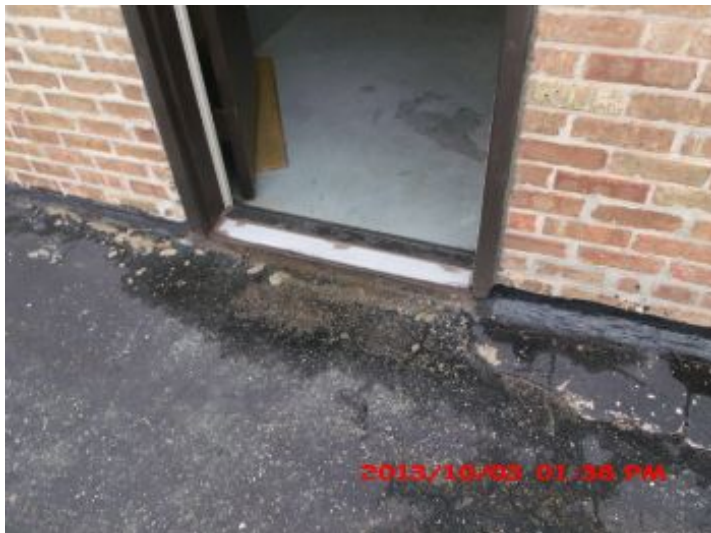
Door sill south side possible puddling

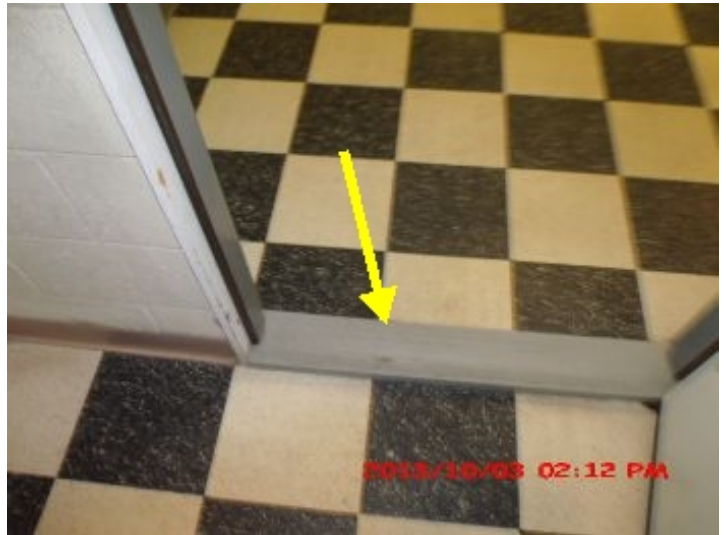
Some office doors trip hazard noted

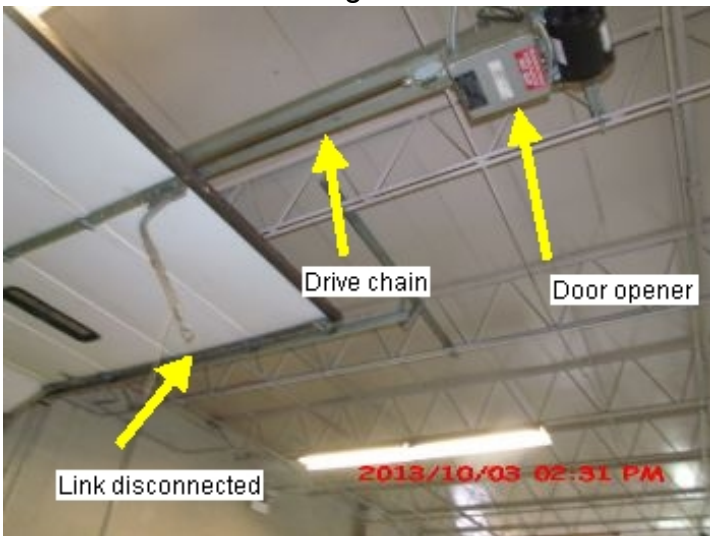
An interior overhead door was noted as disconnect from motor drive chain.
See picture

Interior overhead door south side not connected to opener drive chain

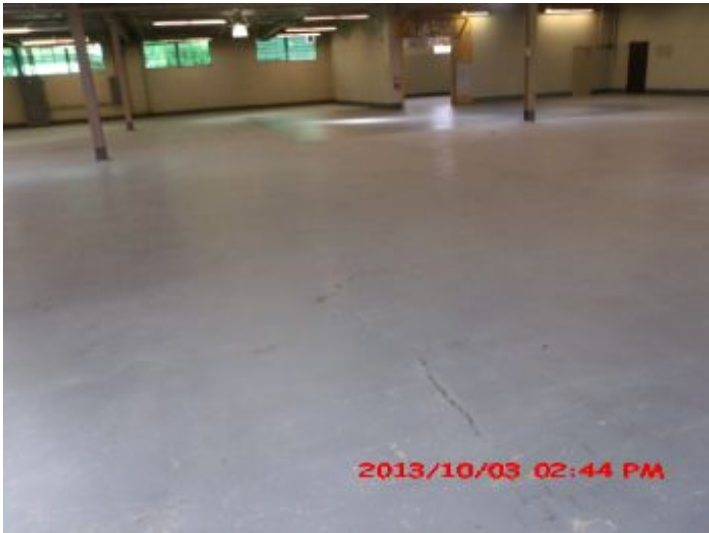
Interior warehouse floor concrete - minor cracks

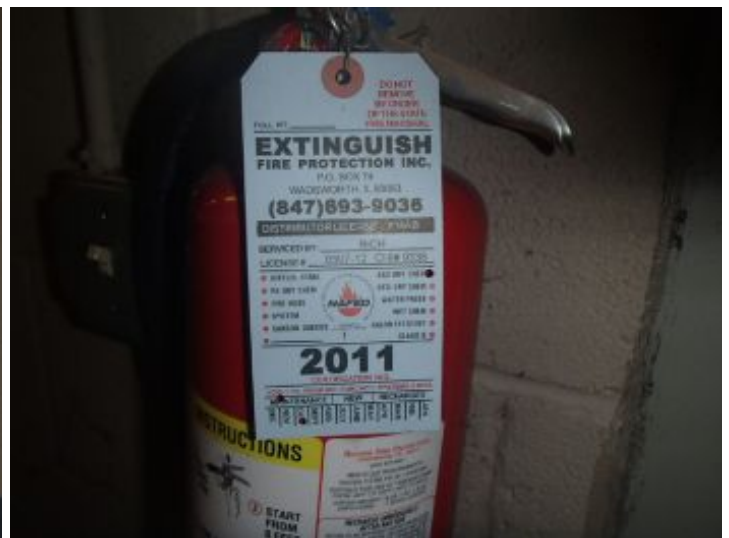
Fire extinguisher service tag expired - Suggest annual inspection of all fire extinguishers

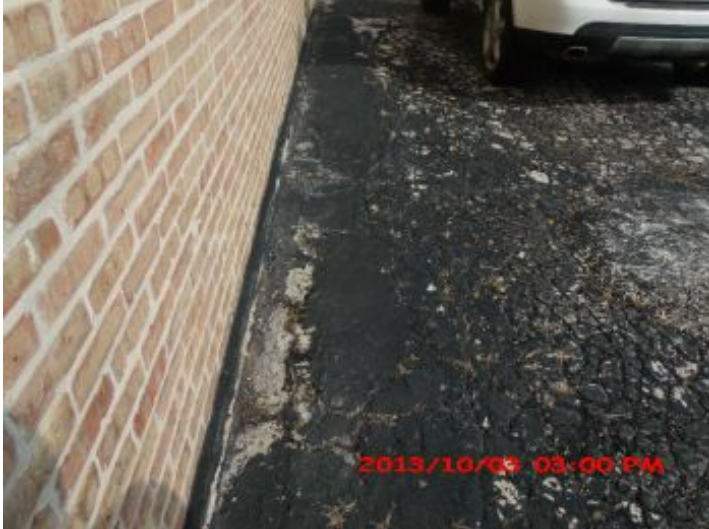
- Asphalt surface badly alleagatoring. Recommend resurfacing

Alligatoring asphalt

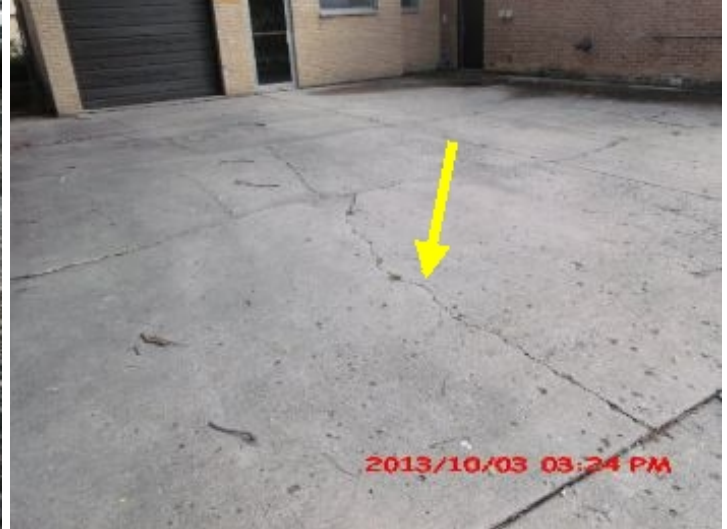
North Driveway - concrete minor cracking

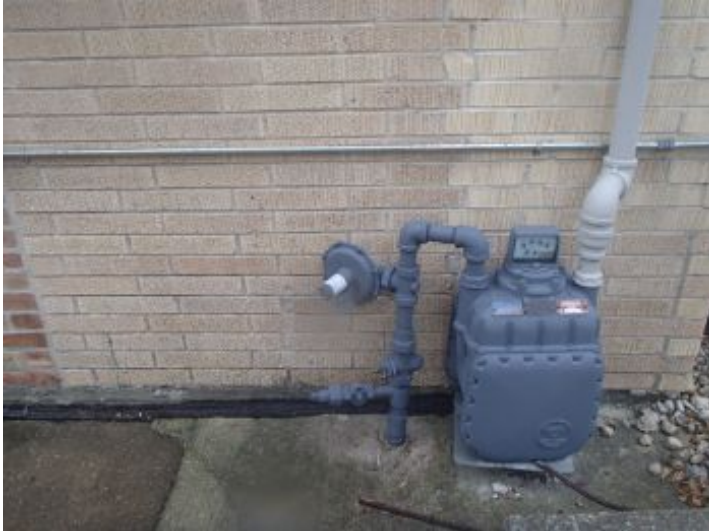
Main gas meter
