Property Inspection Report

1234 N Apple Ave, Chicago, IL 60600

Date of Inspection: 5/6/2013 Time: 12:00PM

This is a sample Commercial property report

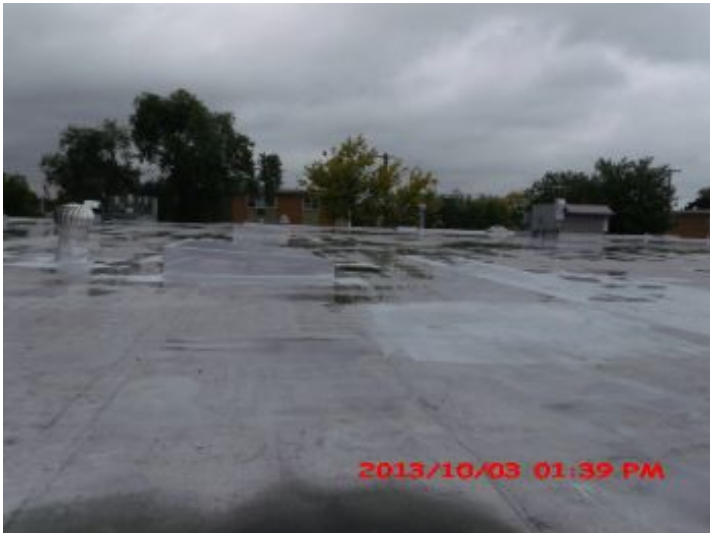
Flat roof with silver coating

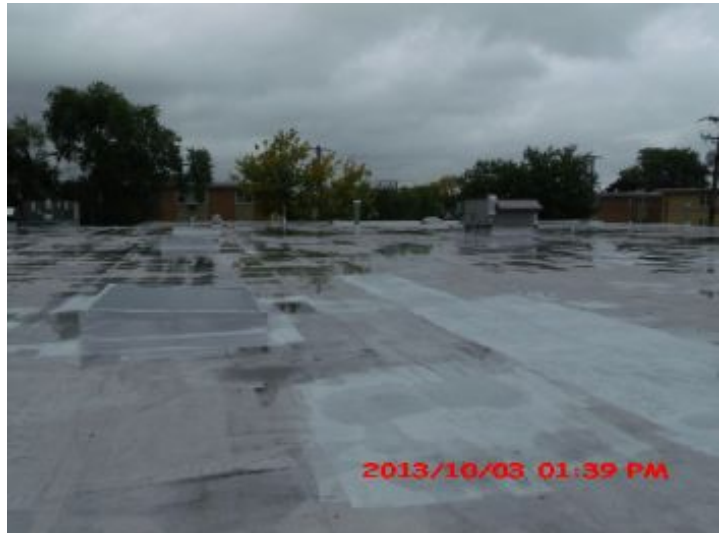
Evidence of puddling

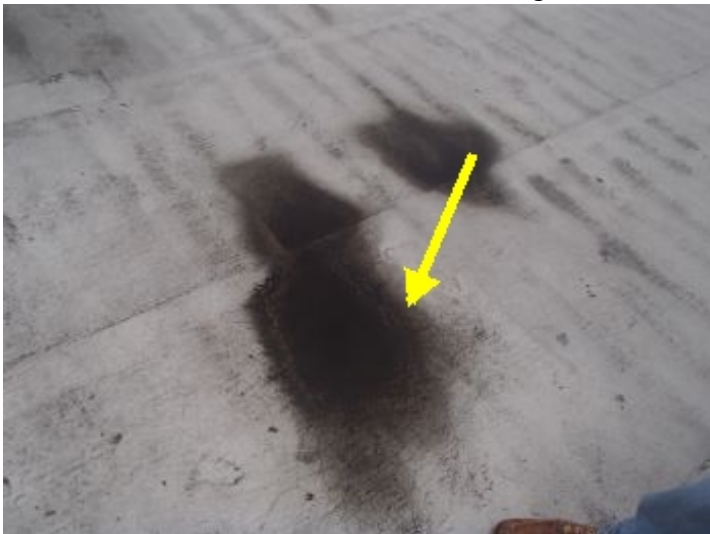
Signs of rooftop puddling

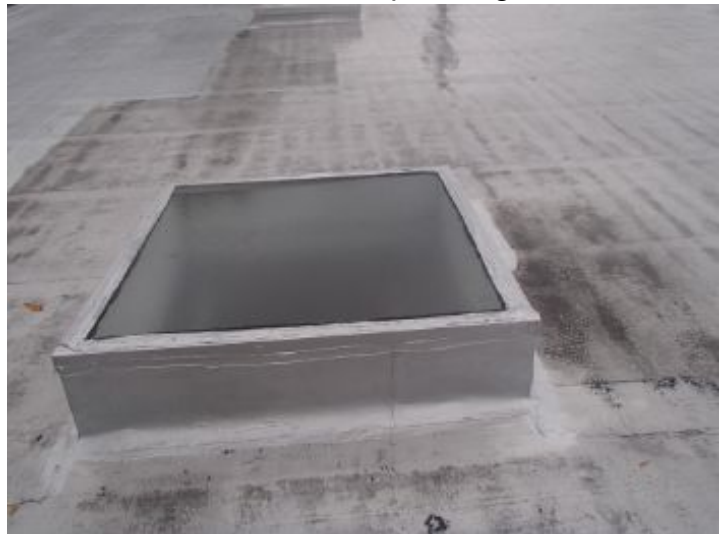
One of several skylights

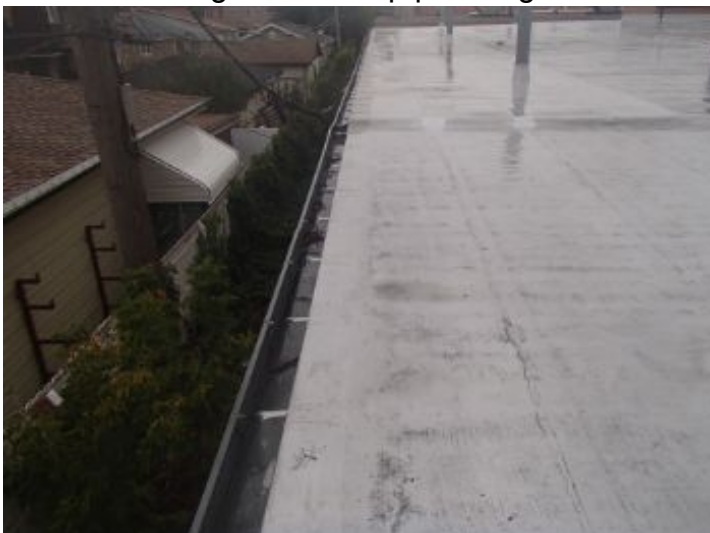
Gutter in rear of building

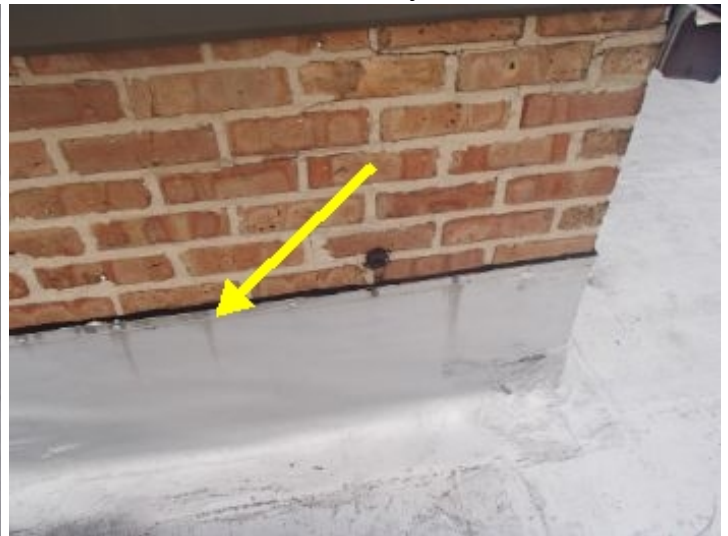
Flashing around roof wall

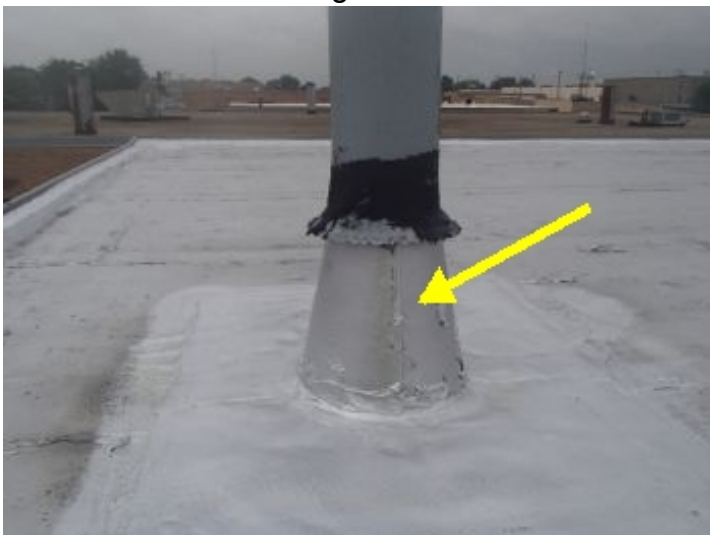
venting flashing

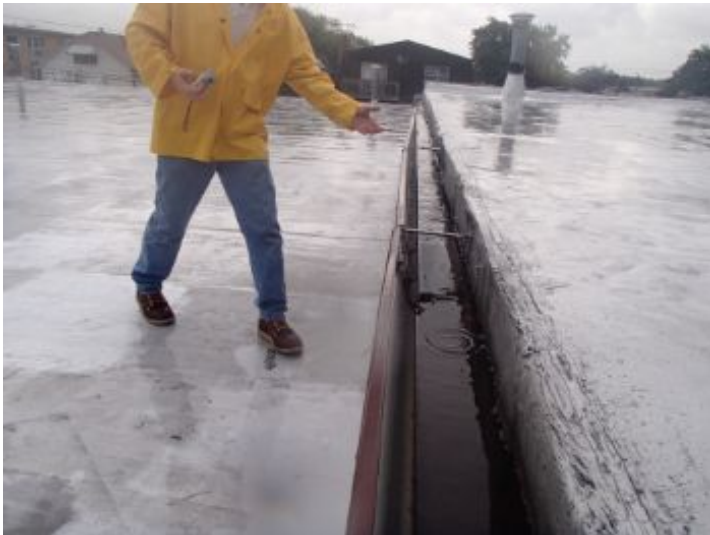
Gutter of higher elevation

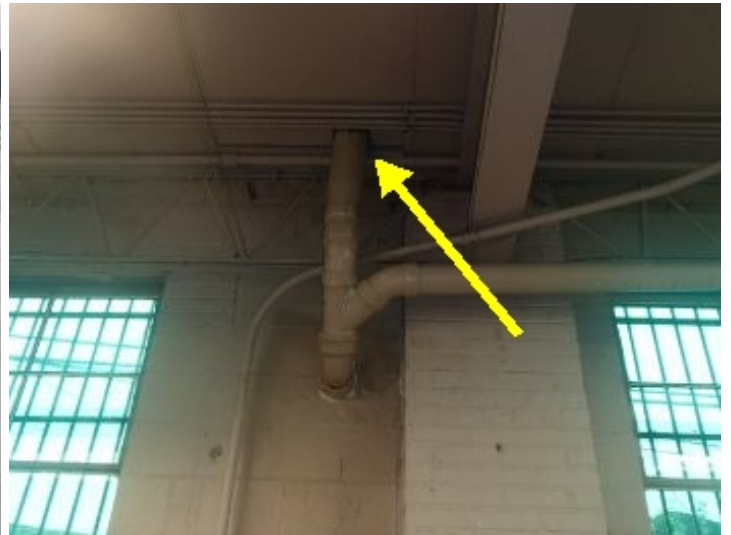
Roof drain pipe

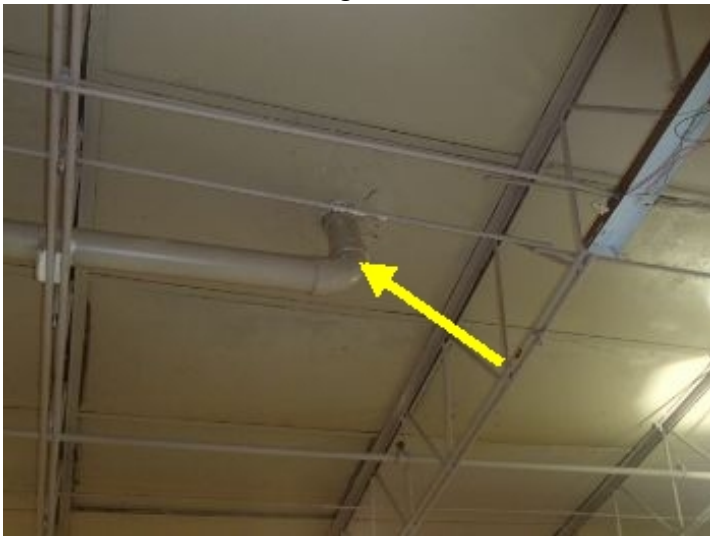
Other roof drain pipe

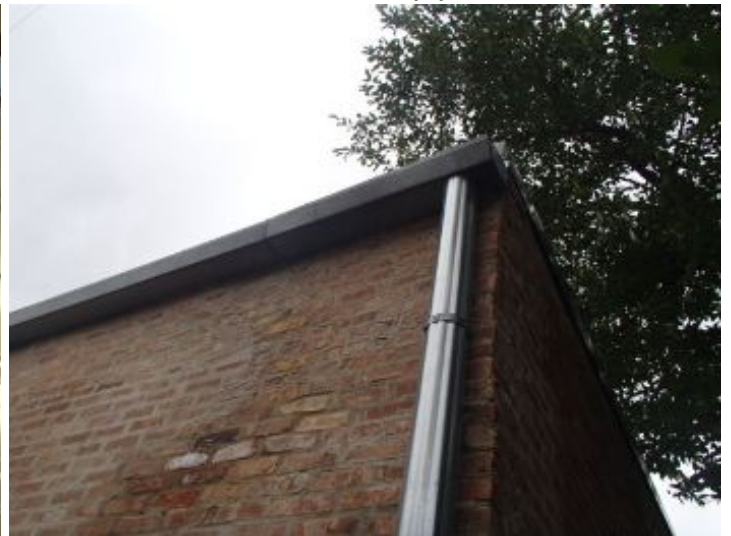
Northeast corner downspout

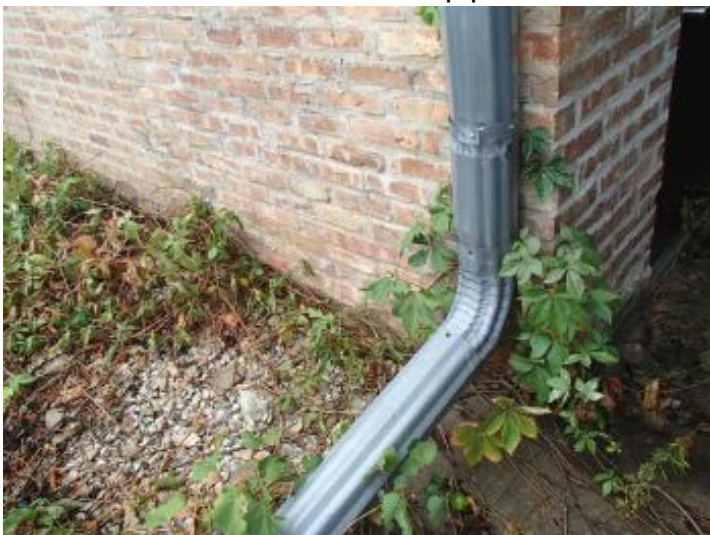
About 5 inch downspout used

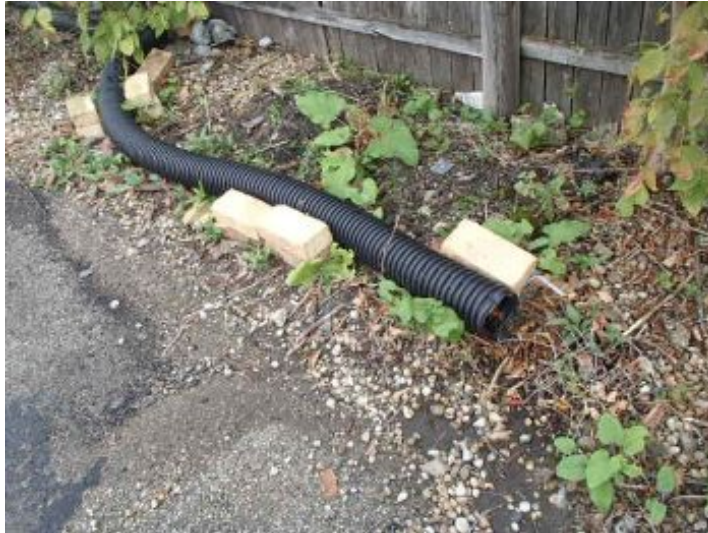
Roof drain water directed to Southeast parking lot. Possibility of ice buildup in winter weather

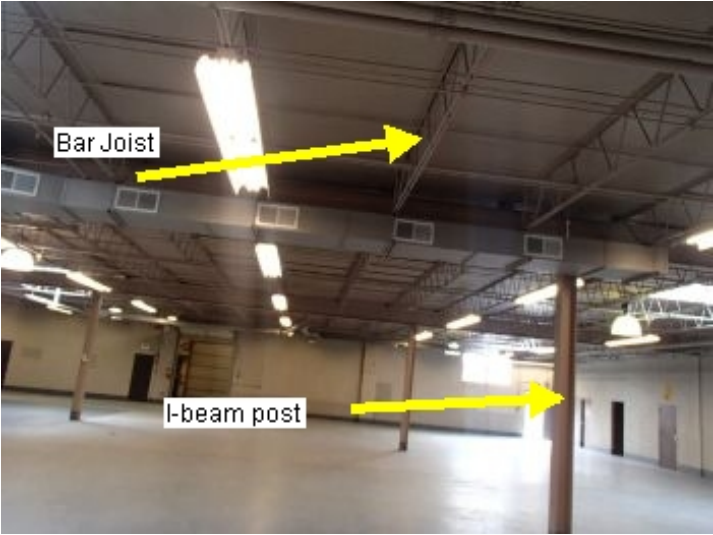
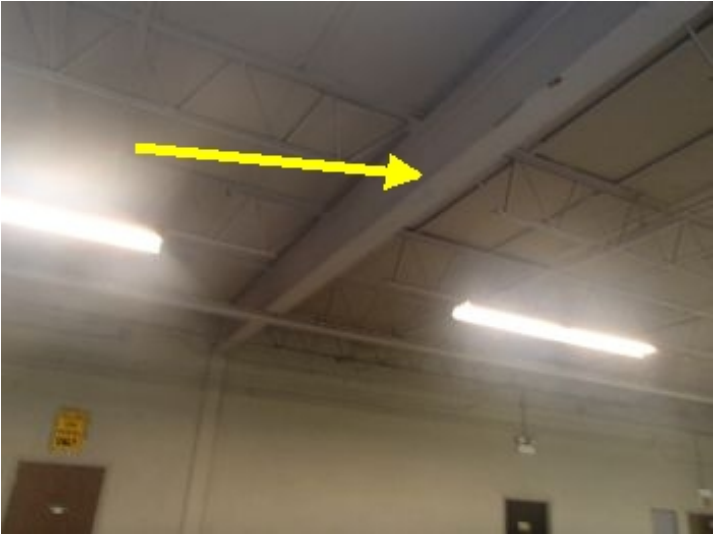
I-Beam girders

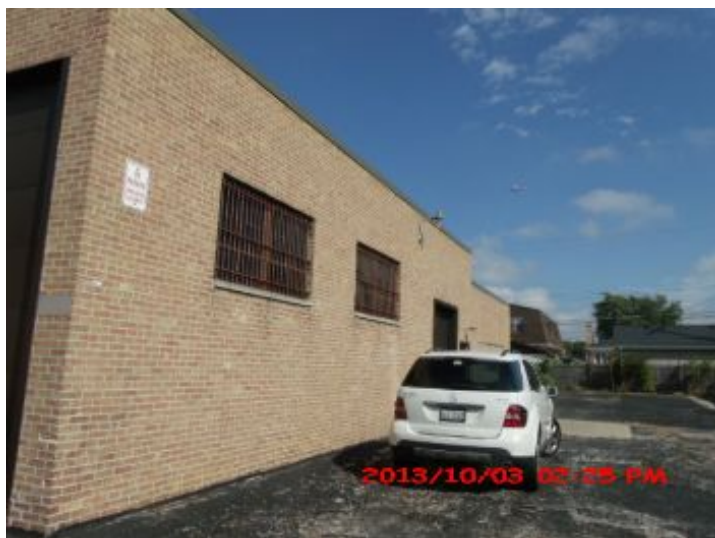
Exterior South Wall

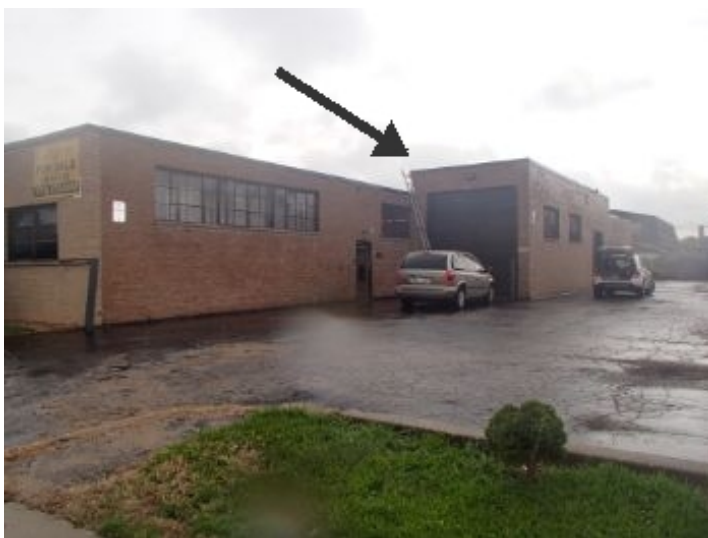
Southeast corner of building showing higher elevation

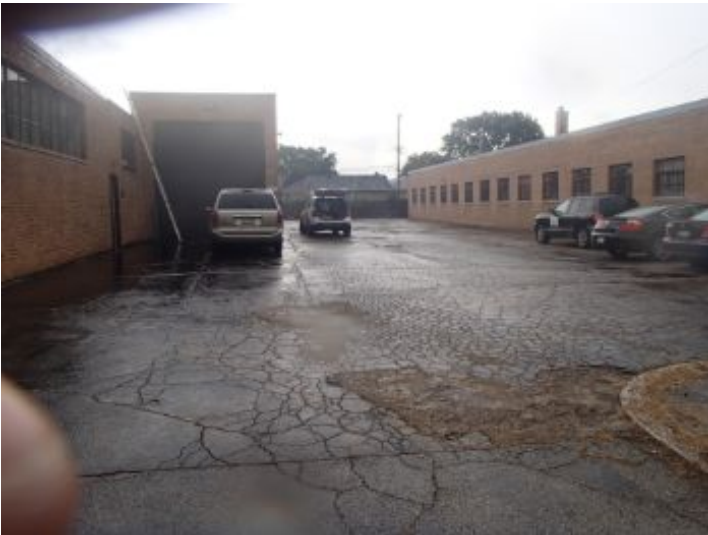
The North parking lot is mostly aged asphalt with severe alligating (numerous cracks resembling alligator skin). Recommend resurfacing.
The south driveway is concrete with common cracks noted

Parking lot asphalt badly alligatoring

Heating and Cooling		
Page 13 Item: 1	Heating and Ventilation	, General concern that some storage rooms do not seem to have heat supply source and may need additional heating source during winter.
Parking lot		
Page 37 Item: 1	Parking lot condition	• Asphalt surface badly alleagatoring. Recommend resurfacing

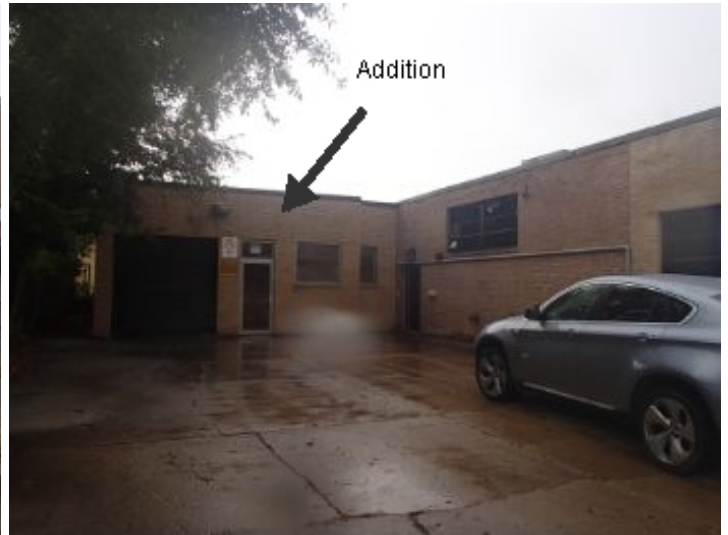
North wall - section addition to original building

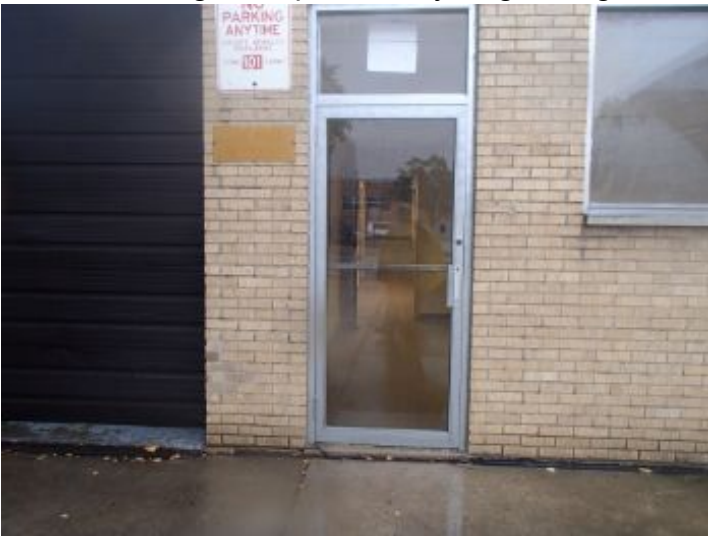
Northeast door

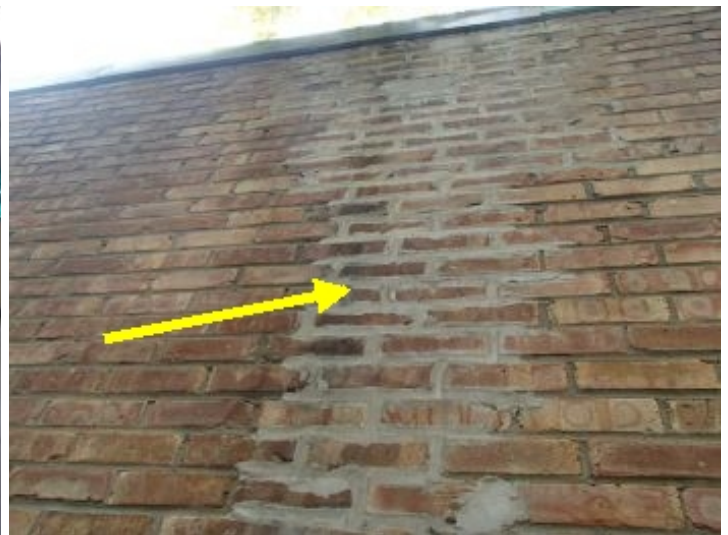
North wall tuck pointing noted

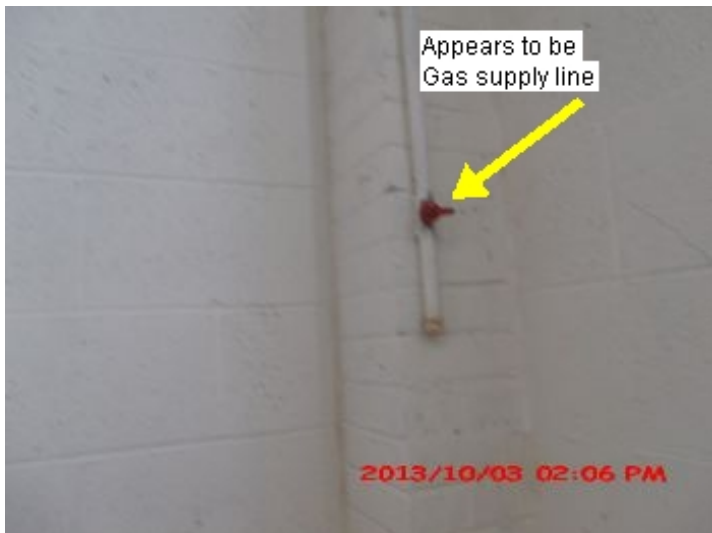
Gas supply to SE room

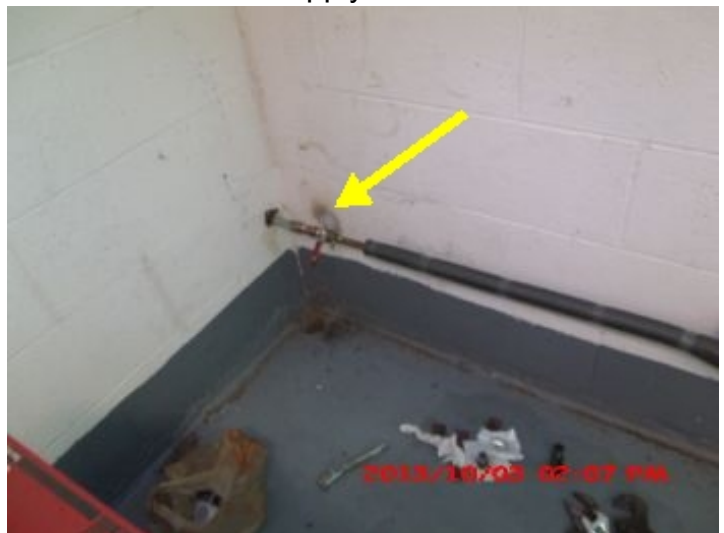
Water pipe in SE room to outside- make sure room heated to prevent pipe line freeze

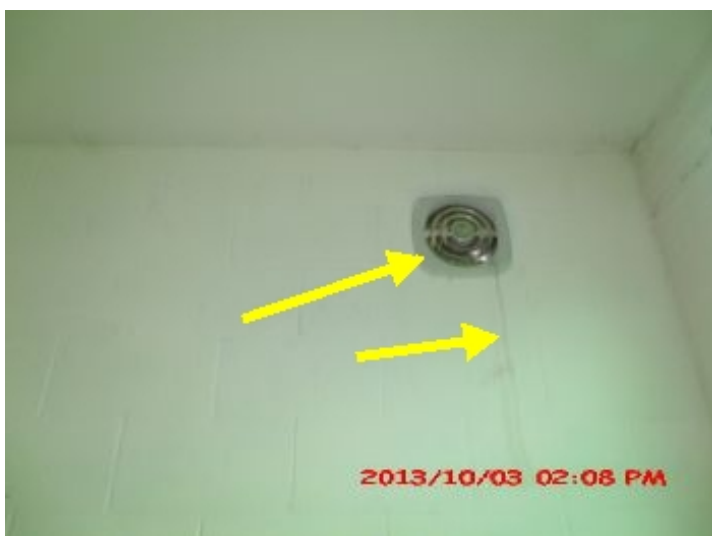
Seems to be only source of heat is vent from next door heated room. Vent fan string did not work

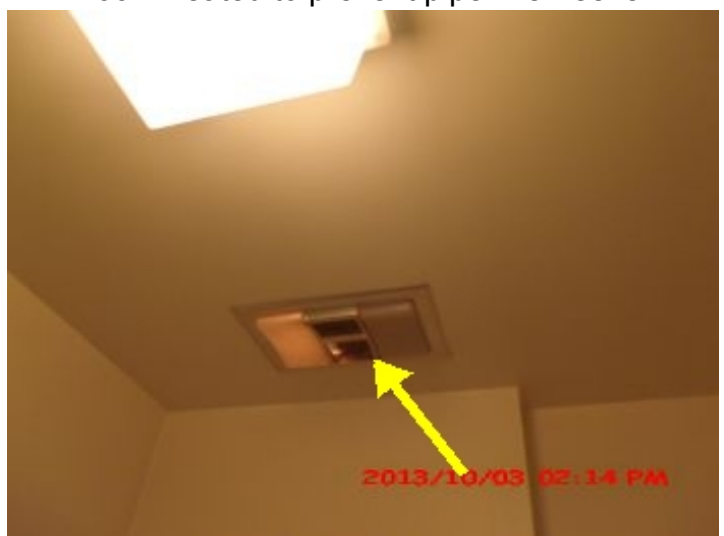
Most restrooms had exhaust fans

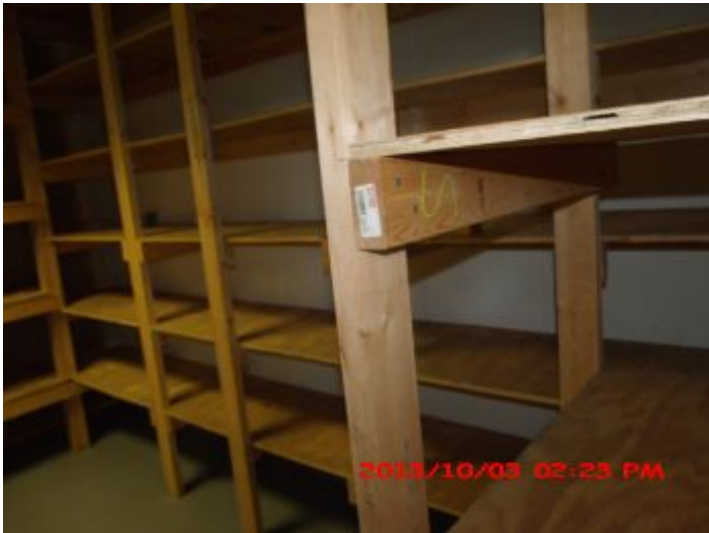
Storage room with shelves

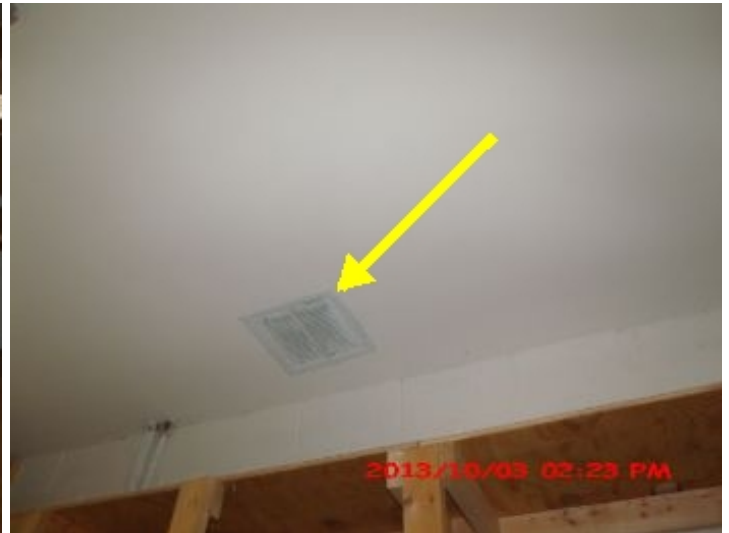
appears to be ventilation in storage room

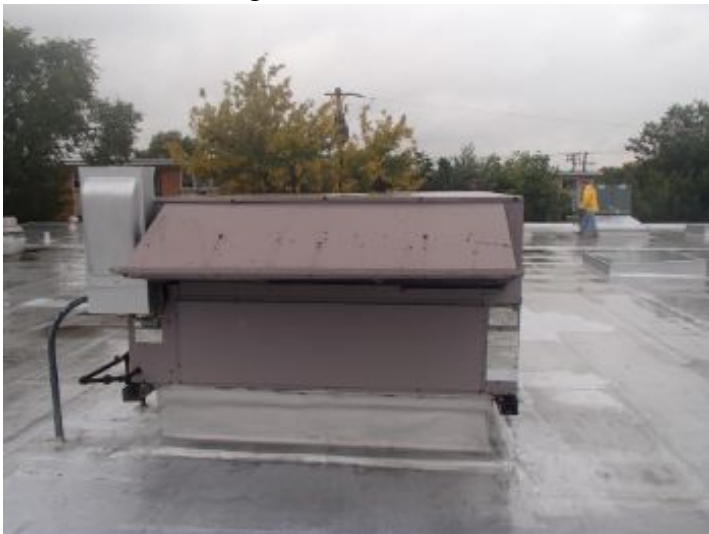
One of two Rheem units 109,400 BTU - over 9 tons

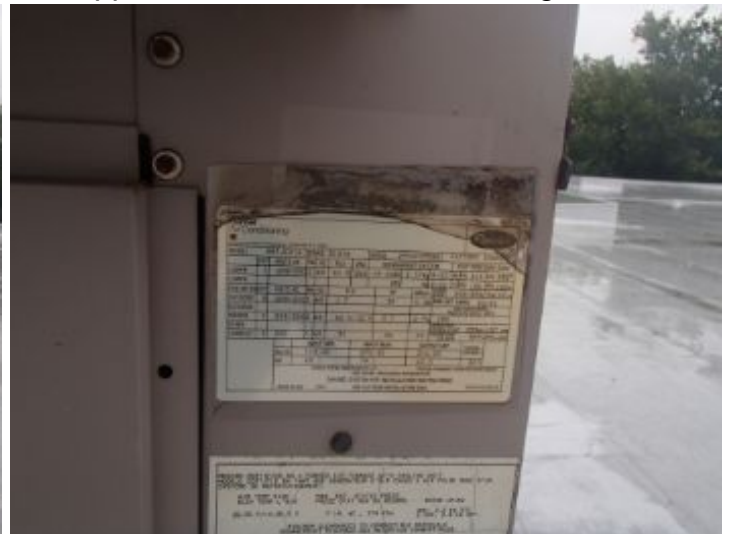
Data sheet for Carrier

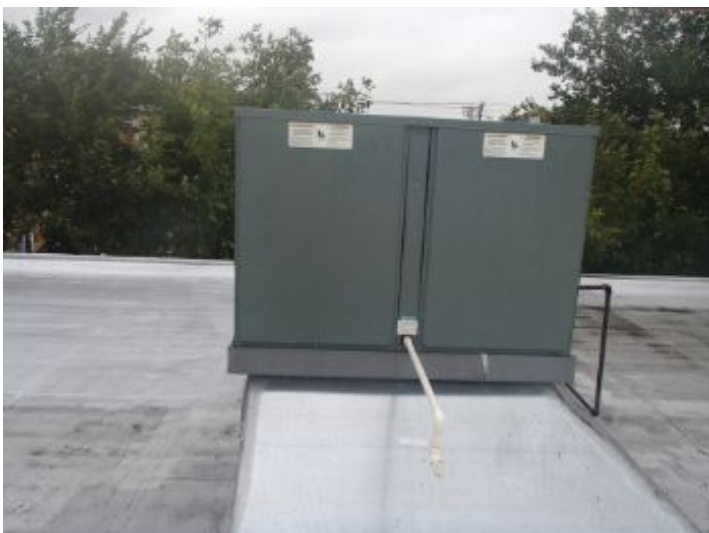
One Carrier Unit servicing Office space

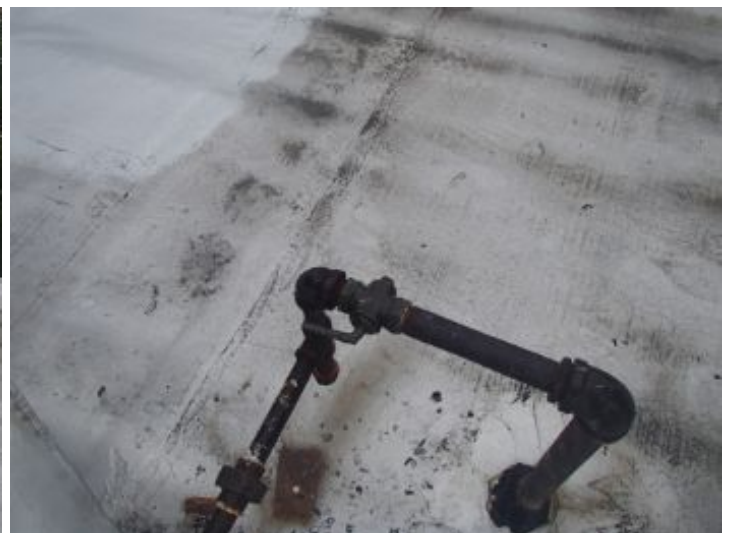
Gas line to Rheem rooftop unit

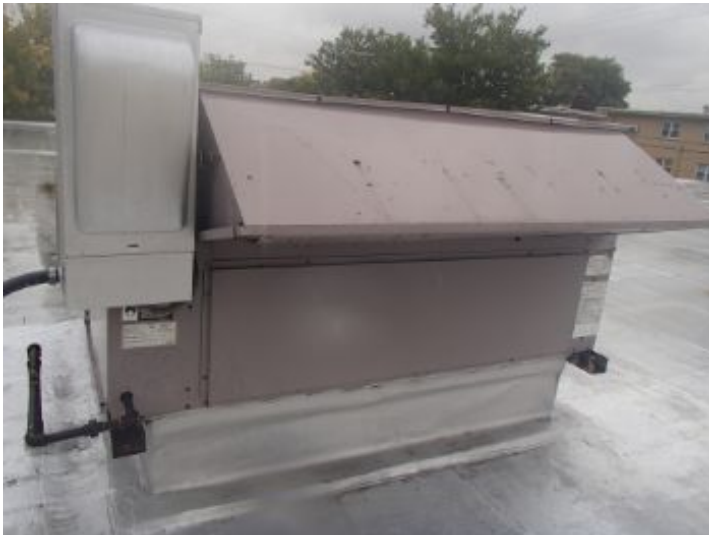
One of two Rheem rooftop units - one is 2011,
one is 2012

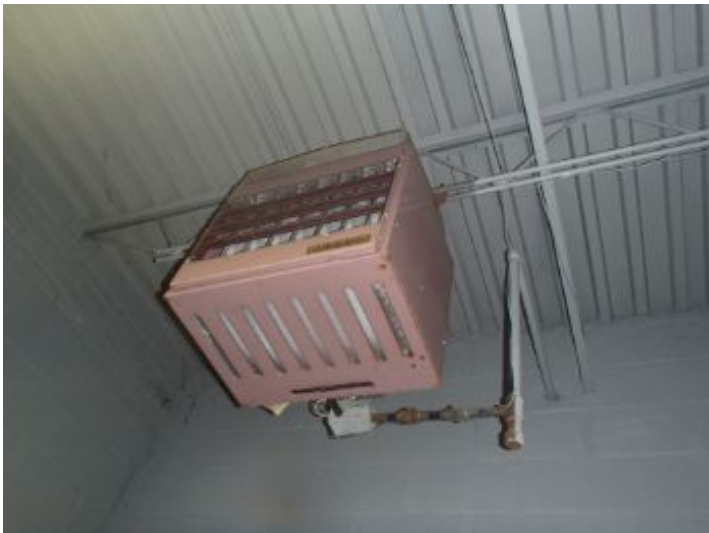
North dock gas space heater - Rezner @ 7 tons -
would not operate at time of Inspection. Possibly
no gas or needs ignition

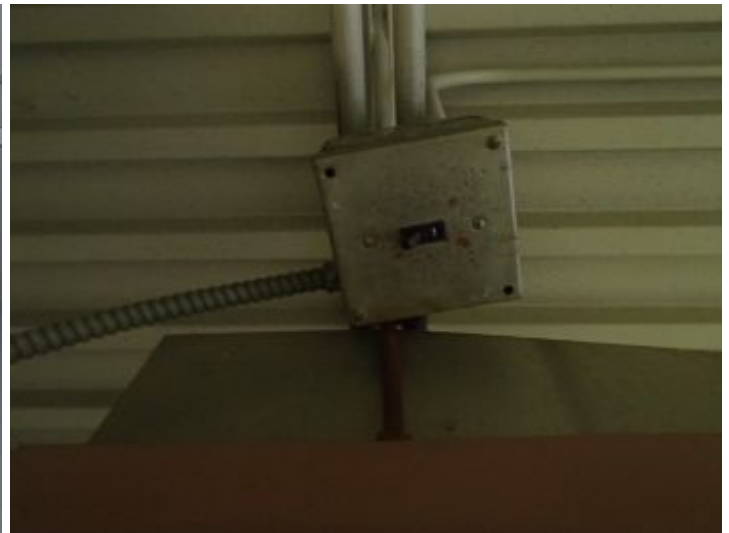
Switch for Rezner space heater

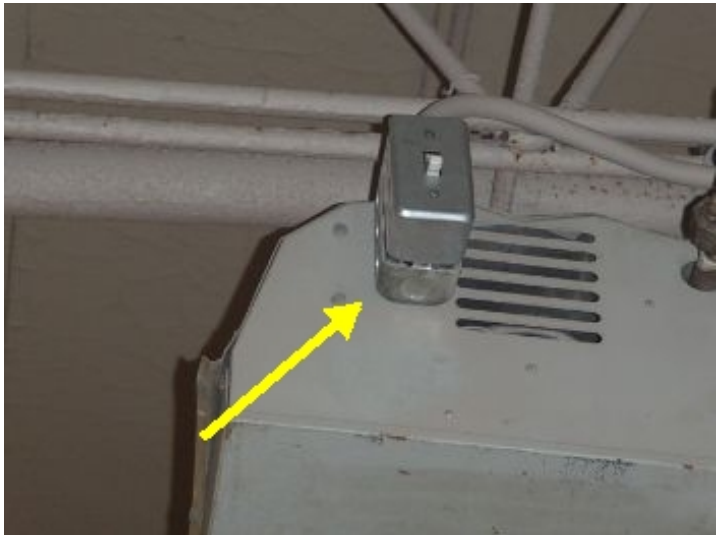
Each of the radiant heaters have on/off switches, reachable by extended hook present

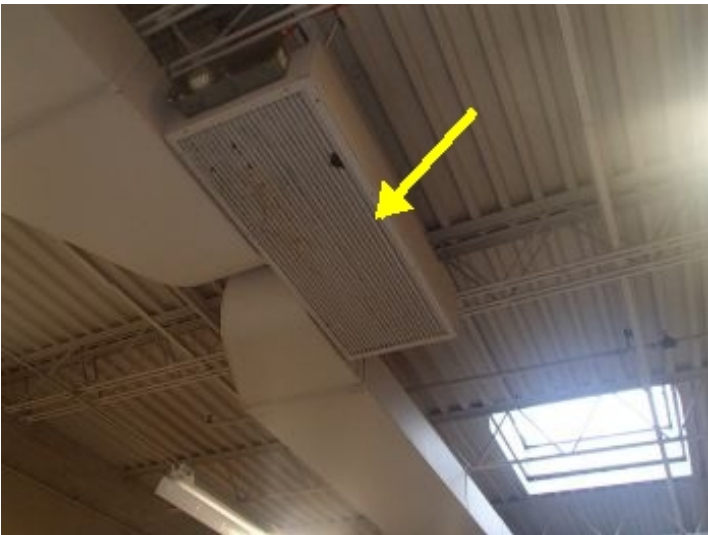
Rheem intake vent

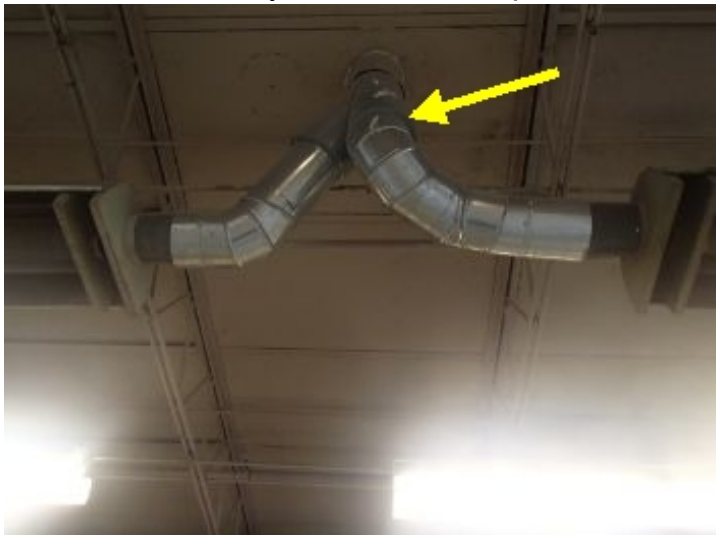
Radiant gas space heater exhaust roof penetration to roof

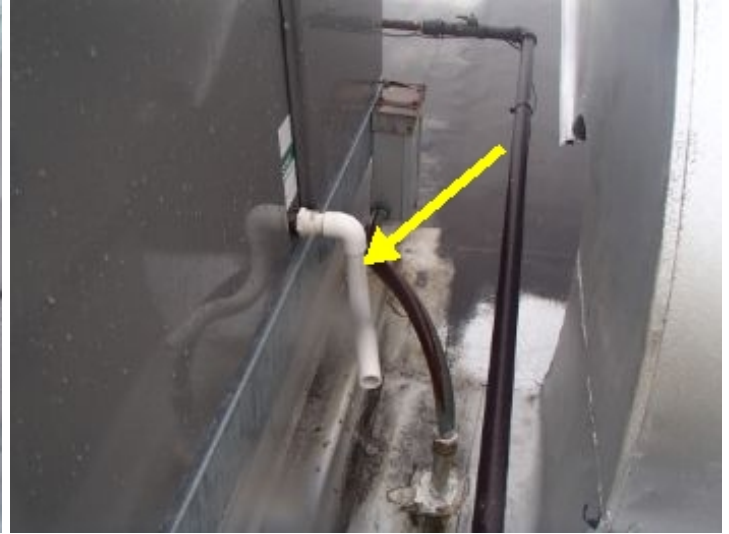
condenser lines

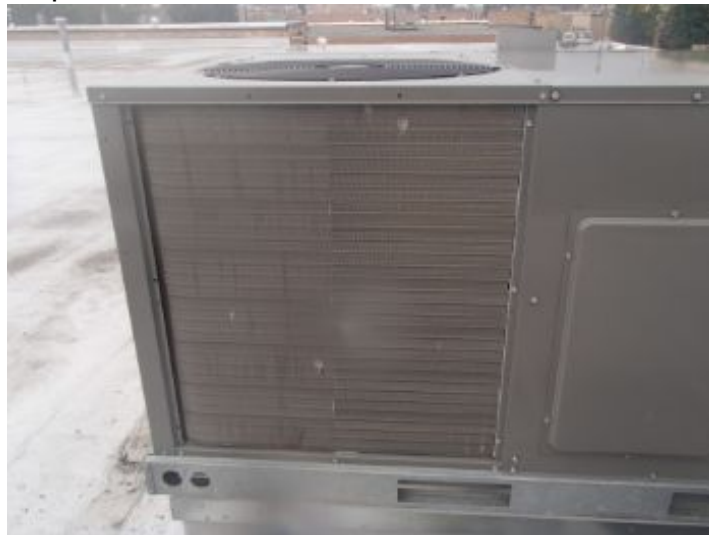
Other Rheem unit - fins are fine

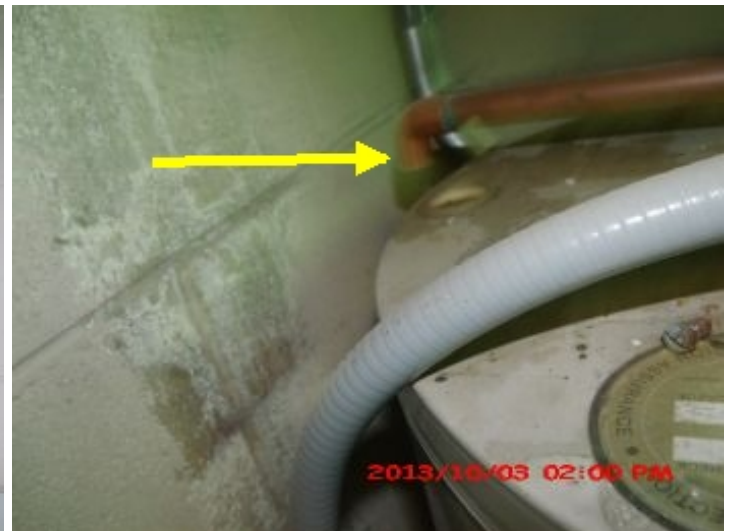
Electric water heater TPRV Valve not extended to floor

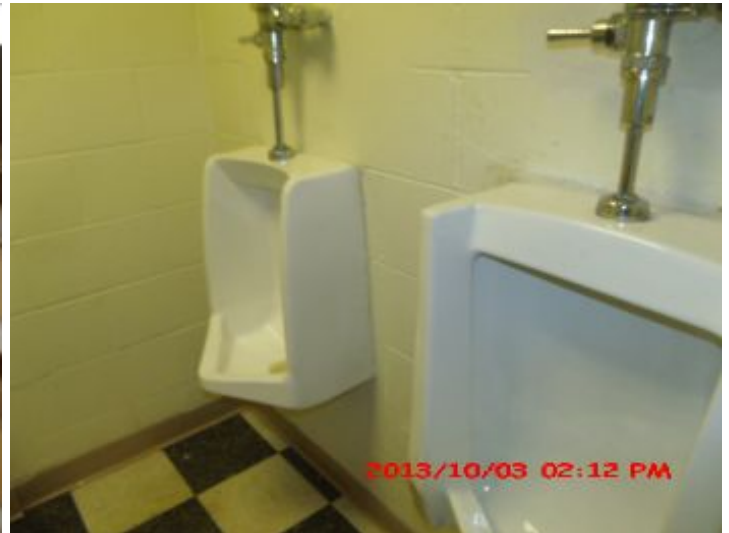
Urinals in mens restroom operated, some slow

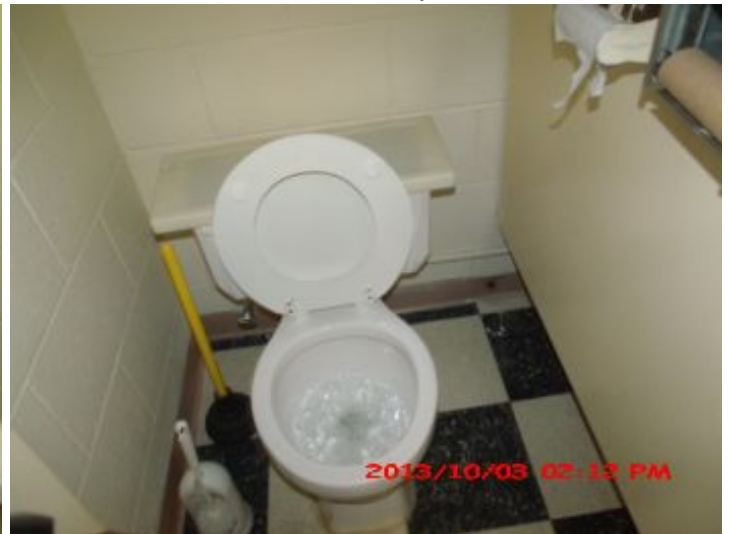
Toilets operated, some a little slow

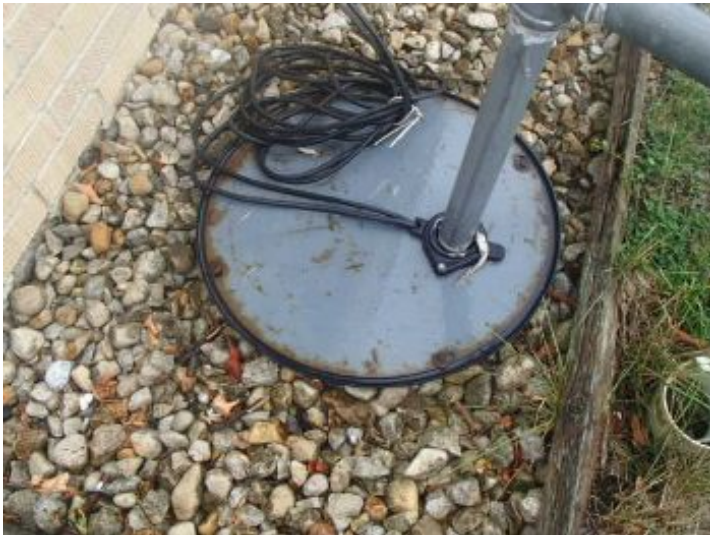
Sump pump feeds into yard drain

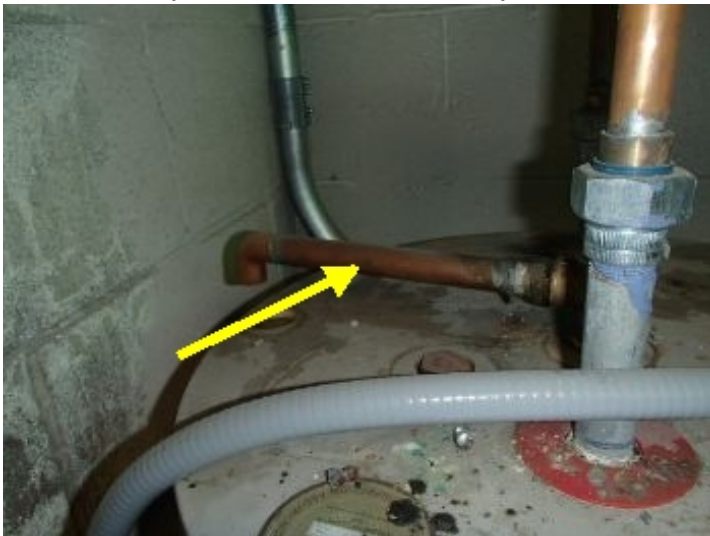
Hot water heater TRPV valve

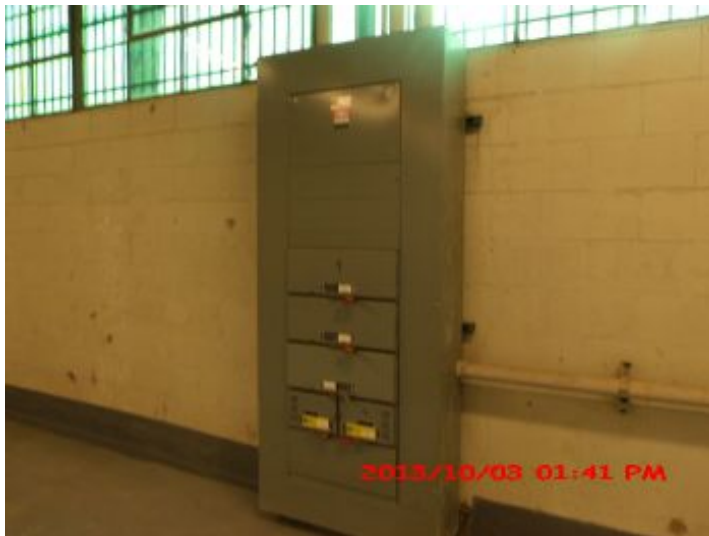
Main panel in rear (east) wall - 800 am service

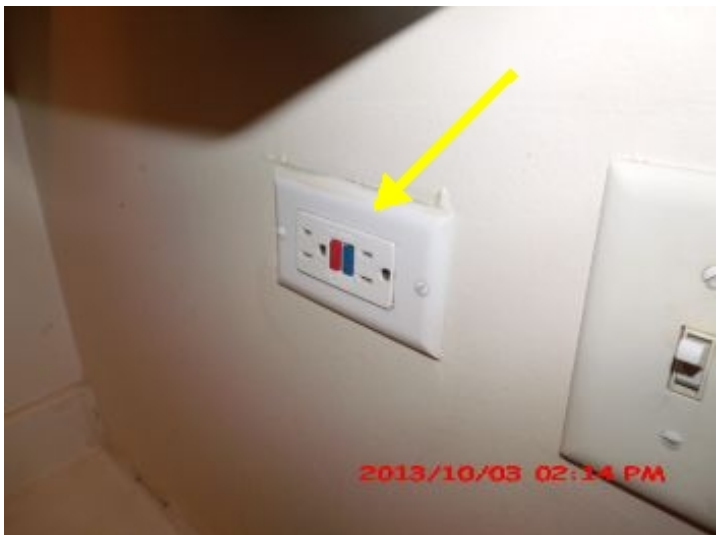
, Most switches and receptacles that were accessible were tested and properly functional at the time of inspection. One of the GFCI ground fault sockets in one of the restrooms was found not to operate properly., Inspector recommends having qualified electrician check dedicated circuits and label branch circuits, In some of the panel boxes, breaker covers were missing. Safety hazard, Halogen lights and fluorescent lights noted in the warehouse area., Noted that most or all of the EXIT signs in the warehouse area were off at the time of the inspection. EXIT signs in office space operated properly.

Some GFCI sockets did not work properly

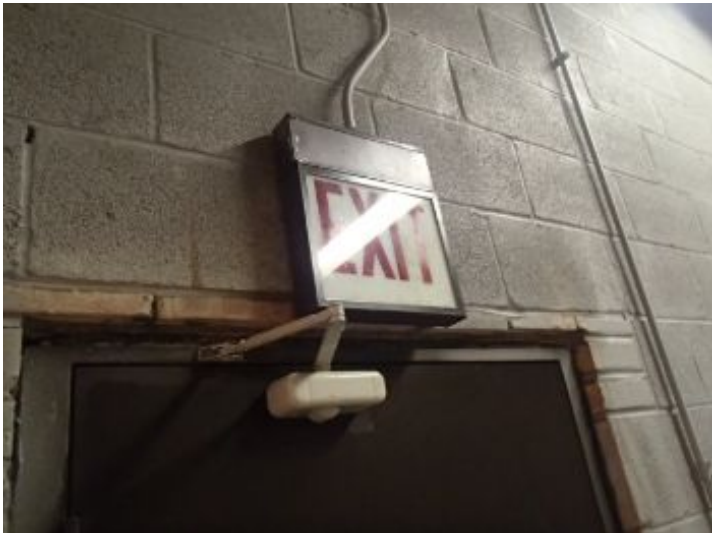
Most of the Exit signs in warehouse were not lit up

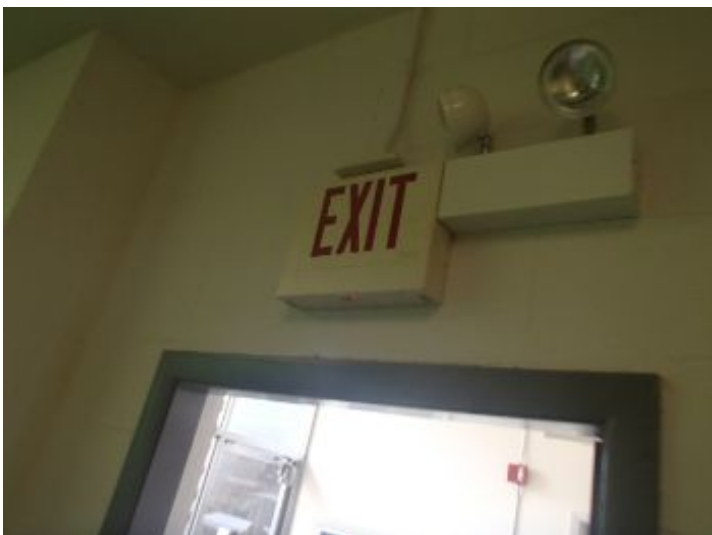
Most Exit lights not lit

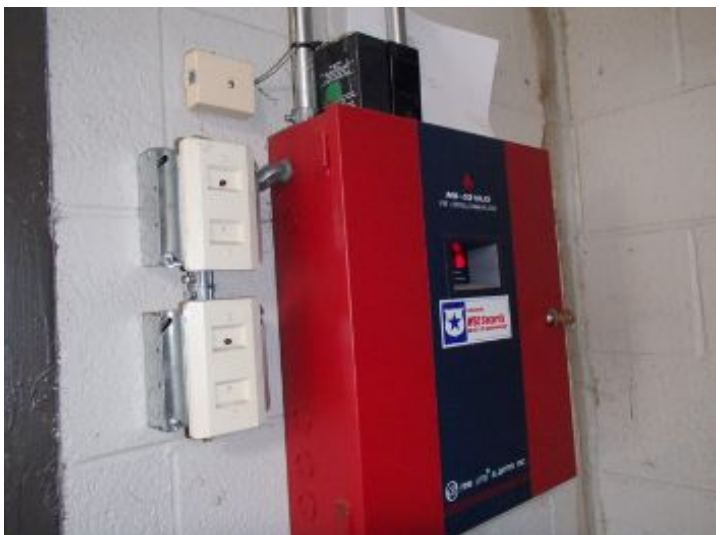
Fire alarm system panel

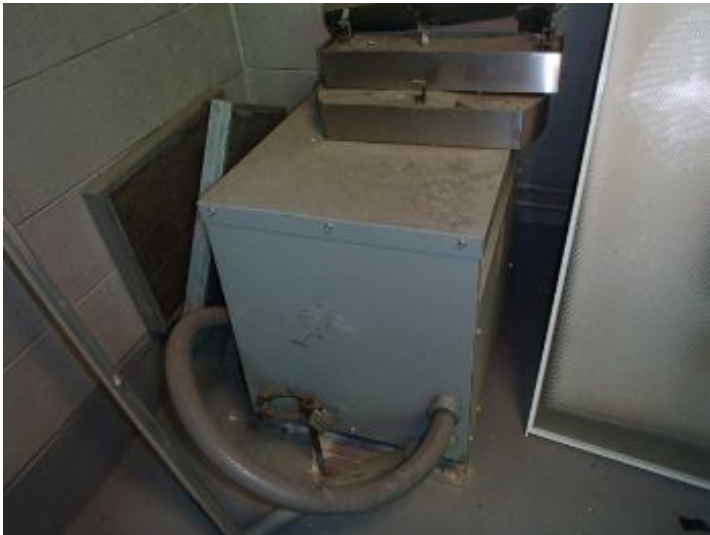
270 volt transformer noted

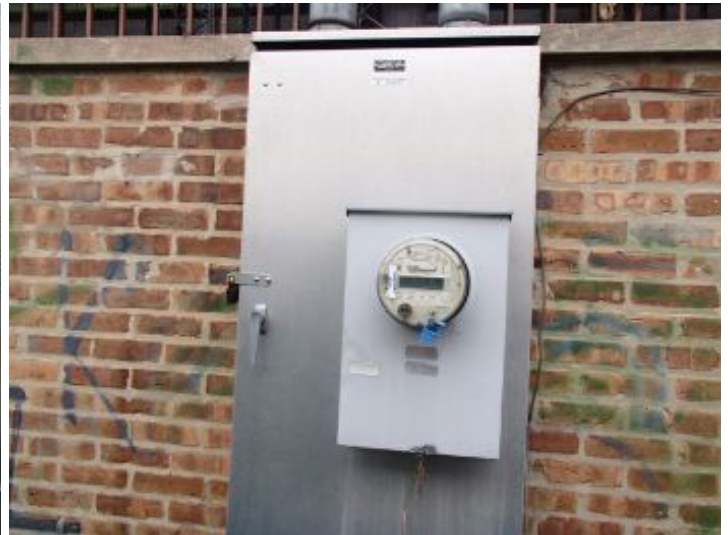
Electrical meter noted west exterior wall

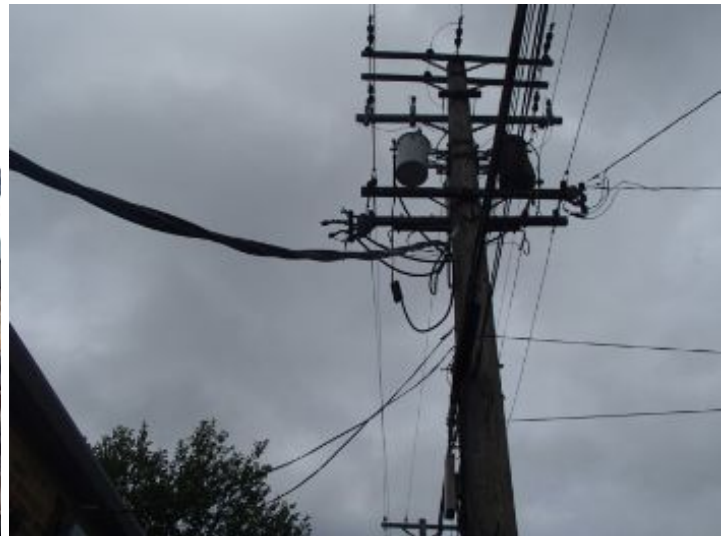
Pole that supplies electrical service to building

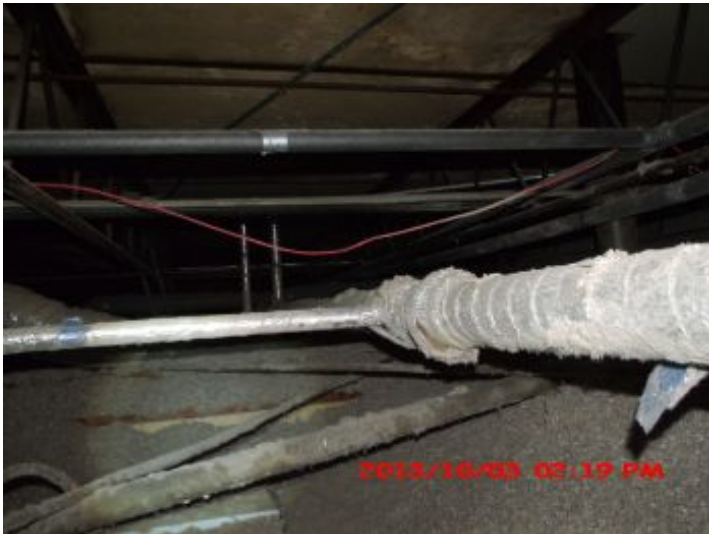
Insulated pipes noted in attic space

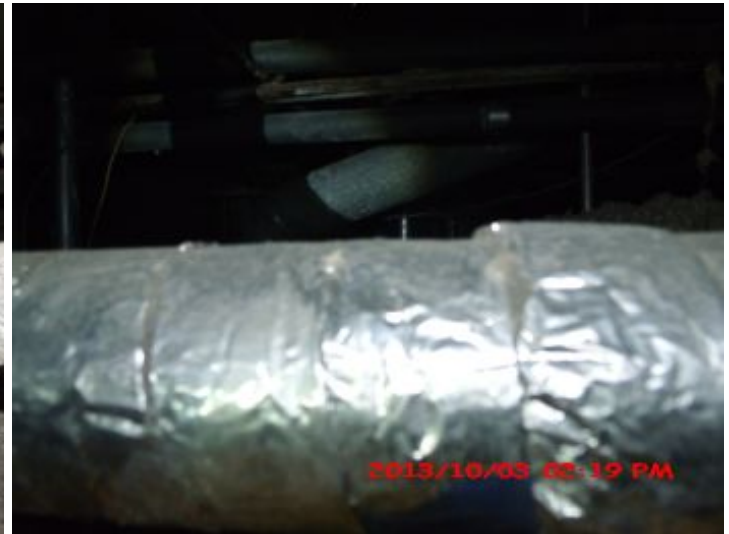
Insulated ductwork noted in attic space over office area

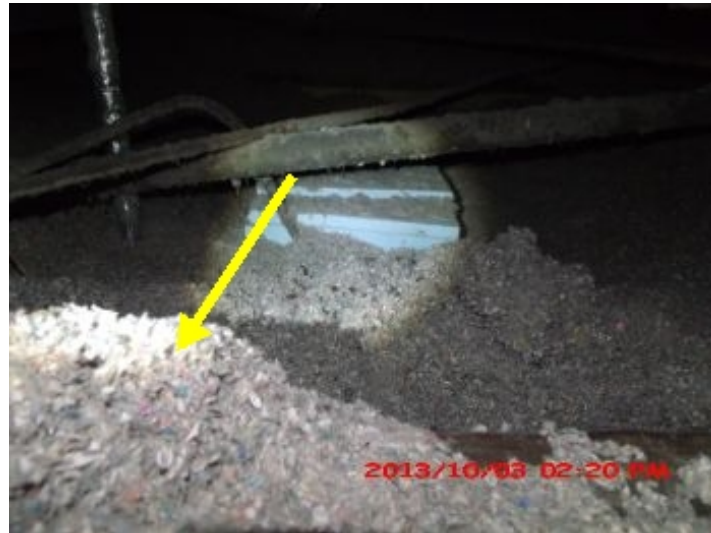
Loose cellulose insulation noted in attic space above office space

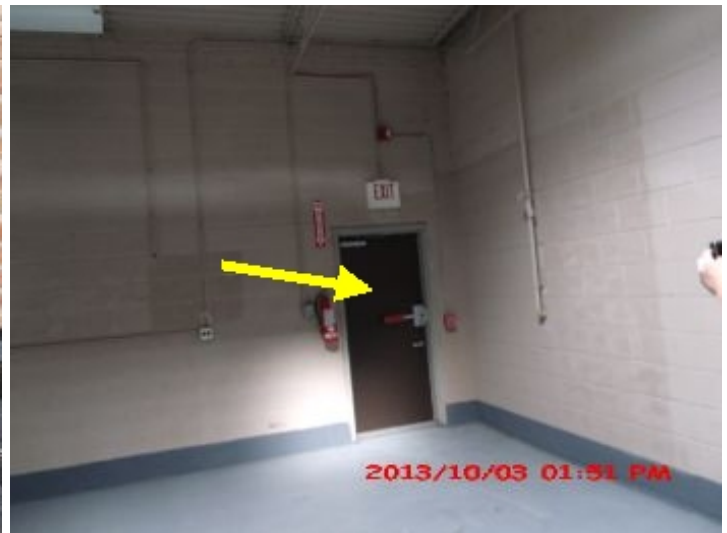
Emergency exit door at Northwest of building

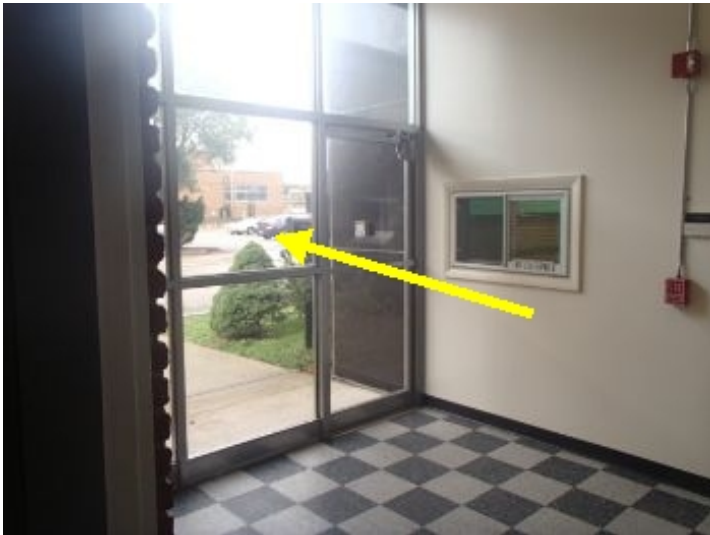
Exterior glass door

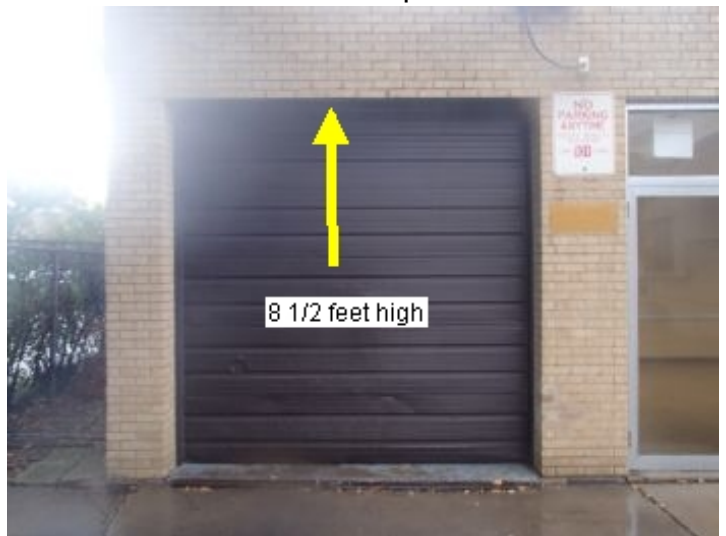
North Overhead door
