Property Inspection Report

1234 N Apple Ave, Chicago, IL 60600

Date of Inspection: 5/6/2013 Time: 12:00PM

This is a sample Commercial property report

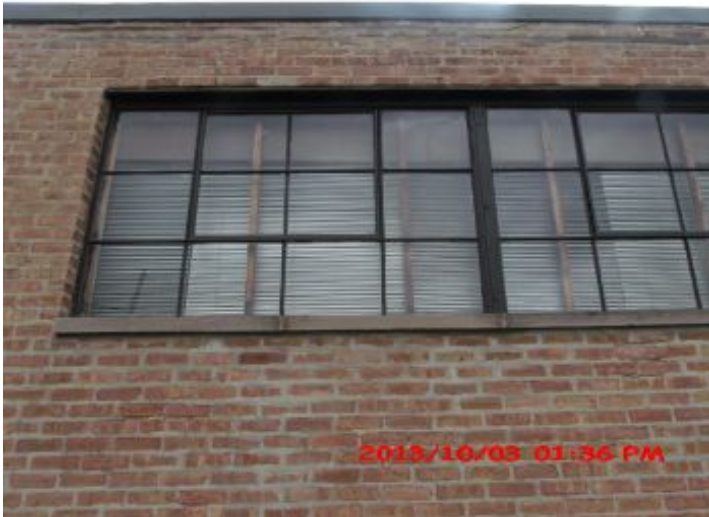
Exterior windows aged but functional

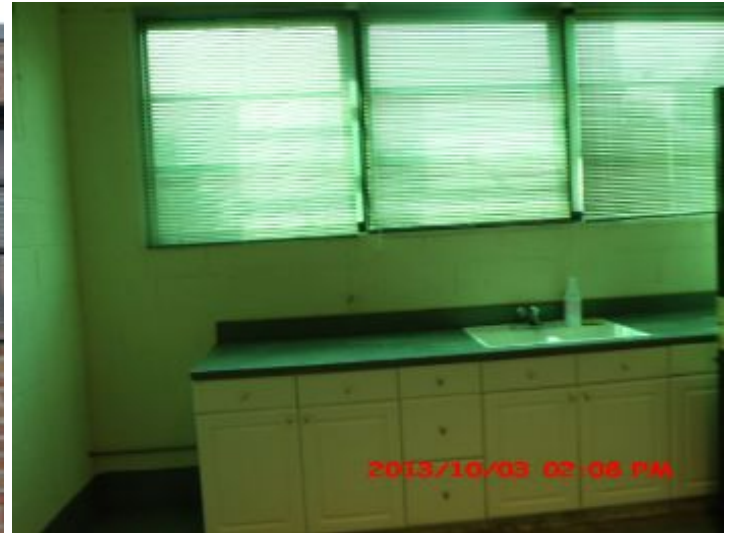
Office area windows

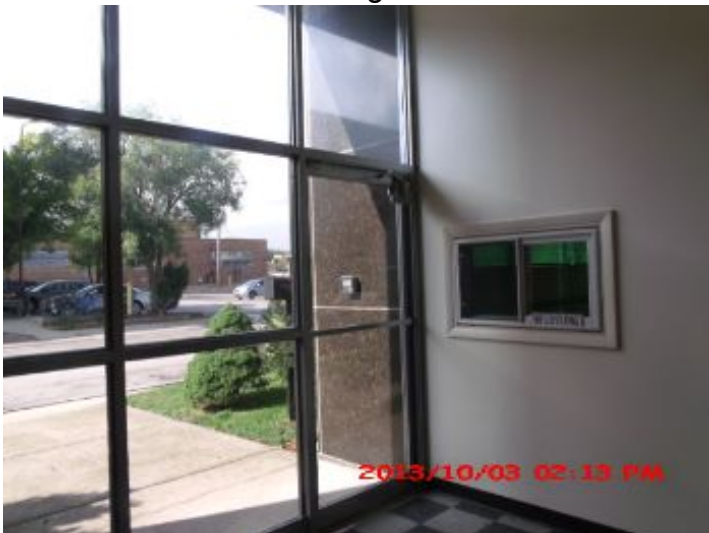
Interior office door and windows

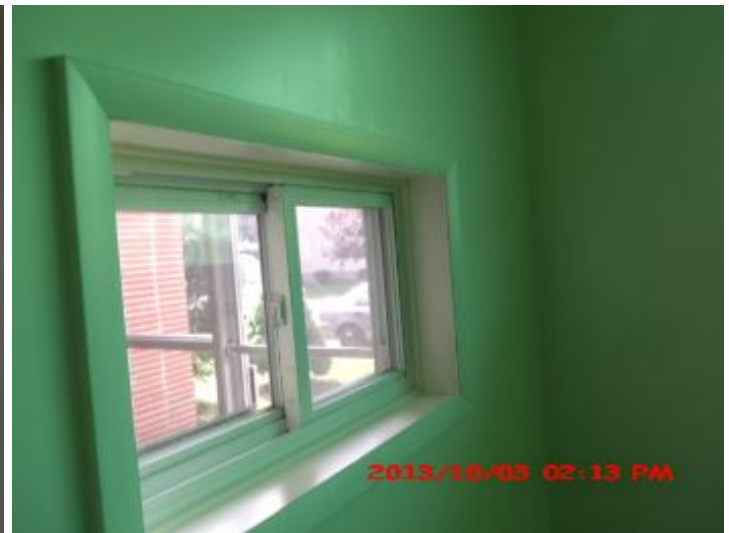
Welcome window from inside

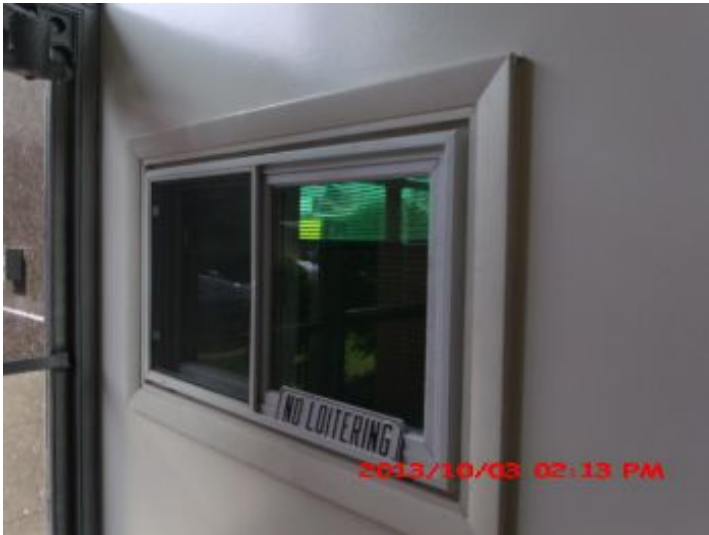
Welcome window from outside

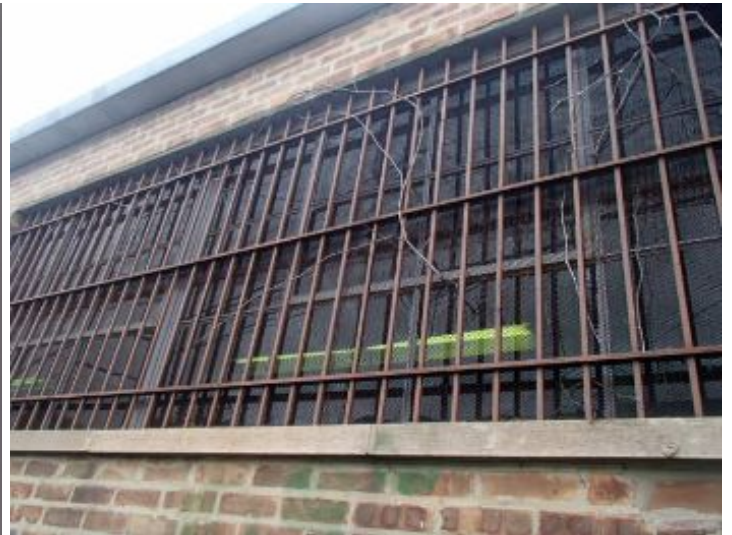
exterior window bars

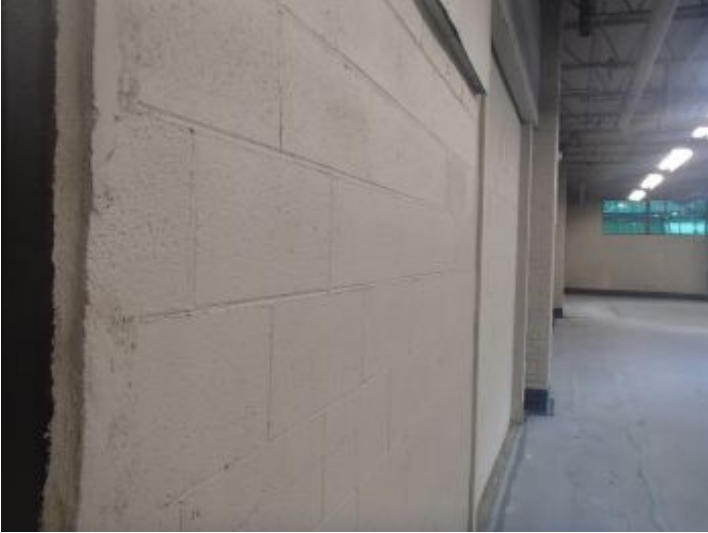
Interior walls of warehouse concrete block

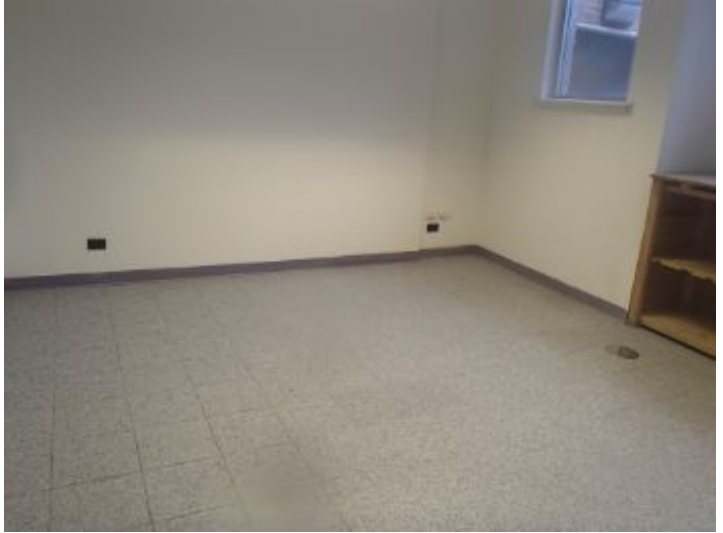
Office space walls drywall

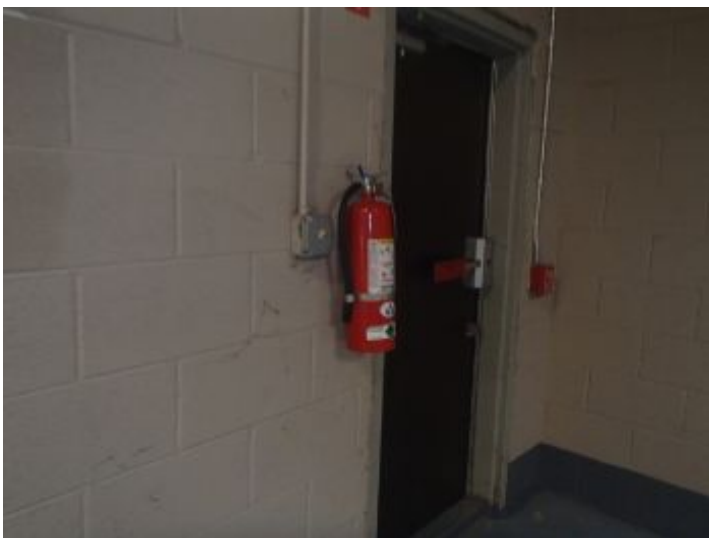
fire extinguishers near exit doors

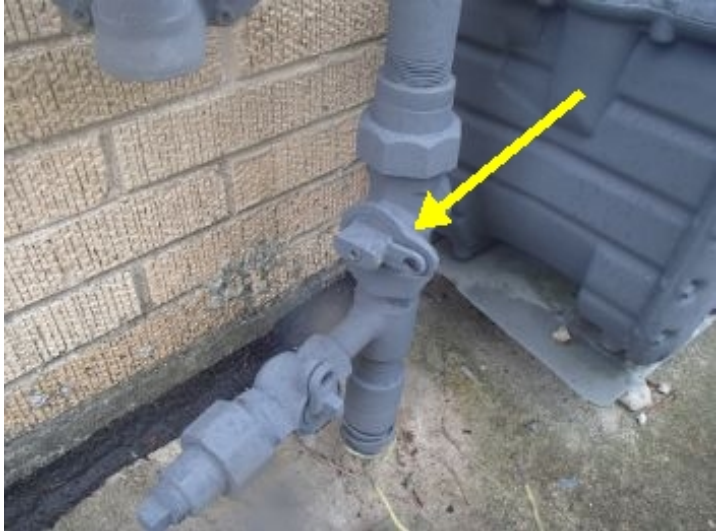
Main gas meter was shut off - owner turned on during inspection

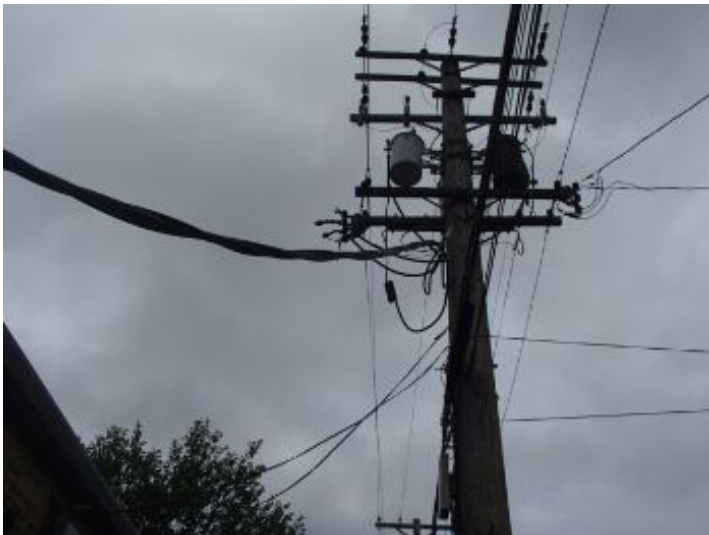
Electrical service pole in rear (west) of building

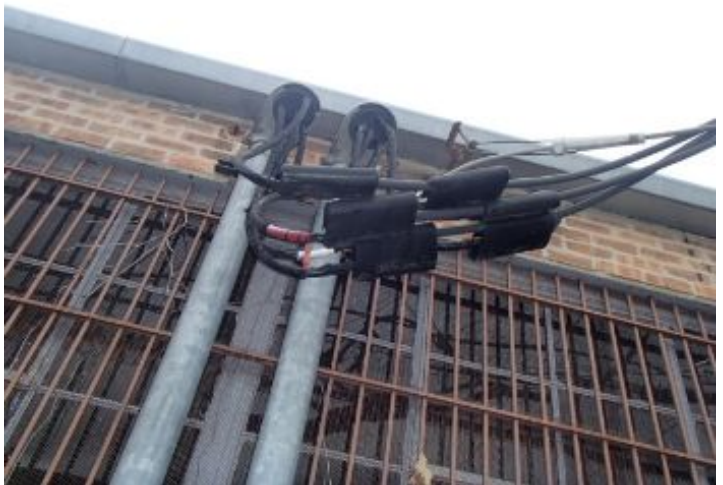
Electrical service to building - overhead mast
